POLICE STATION NEEDS ASSESSMENT STUDY FOR

**CARVER
POLICE DEPARTMENT**

5. LIST of PRESENT CARVER POLICE STATION DEFICENCIES and EXISTING CONDITIONS

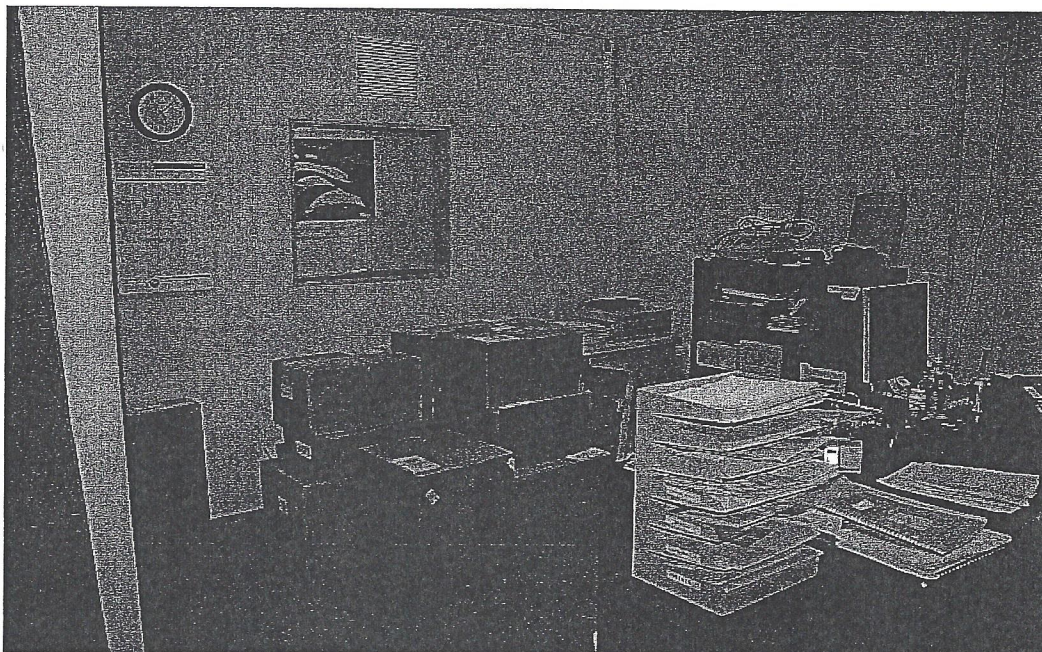
Administrative Assistant's Office used as a catch all for any deliveries and storage.

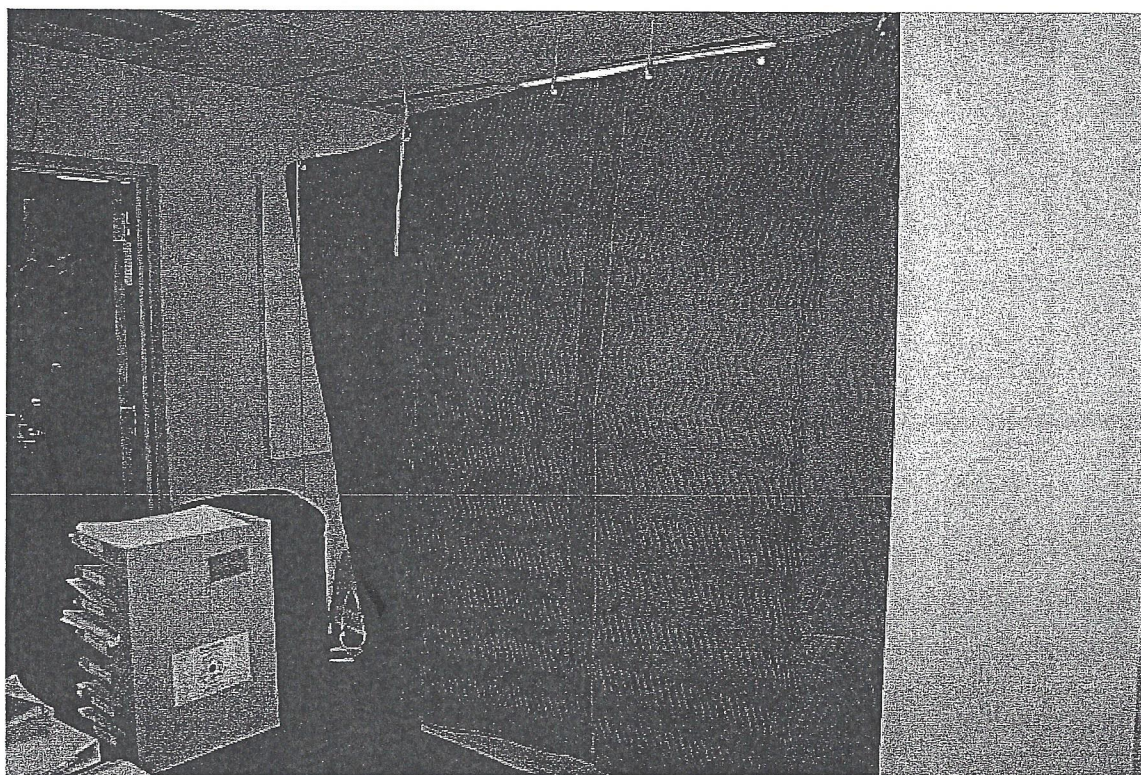
Computer servers and other infrastructure are assembled behind this curtain in an area of the Administrative Assistant's office designed for office supplies. The curtain is to reduce the noise level from the machines the Administrative Assistant must listen to.

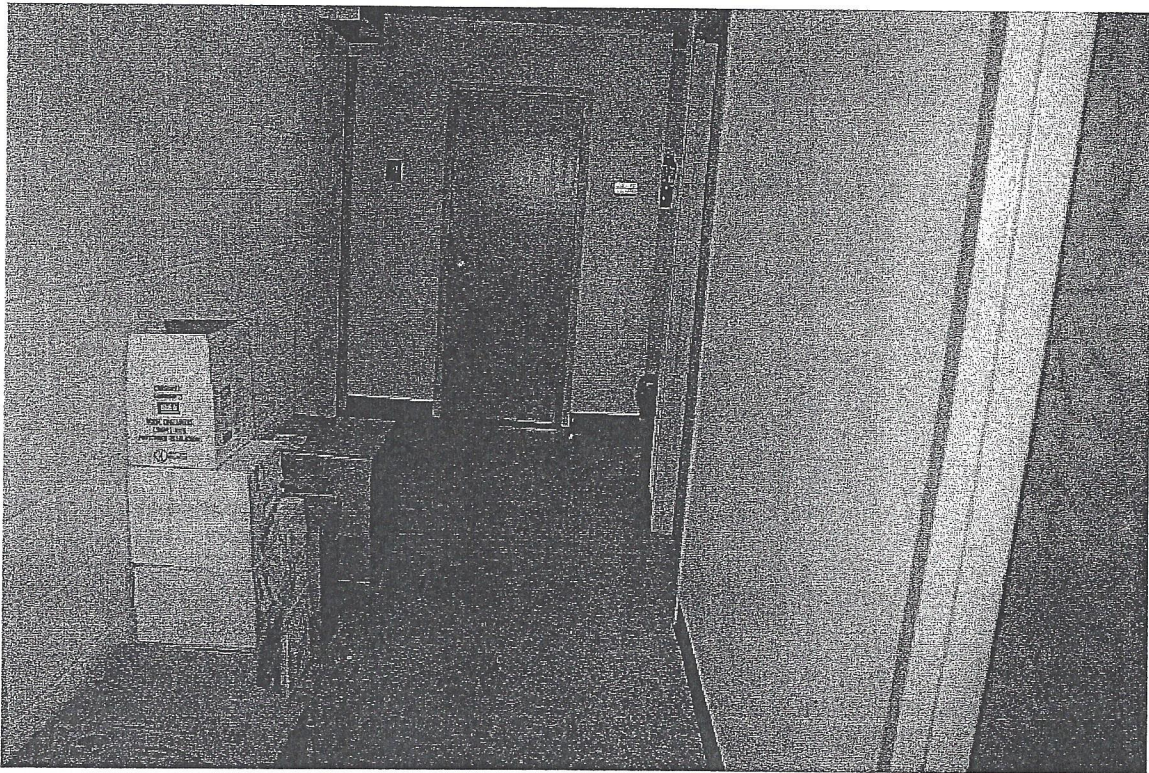
Office and other supplies are required to be stored in the hallway to accommodate for the lack of proper storage space.

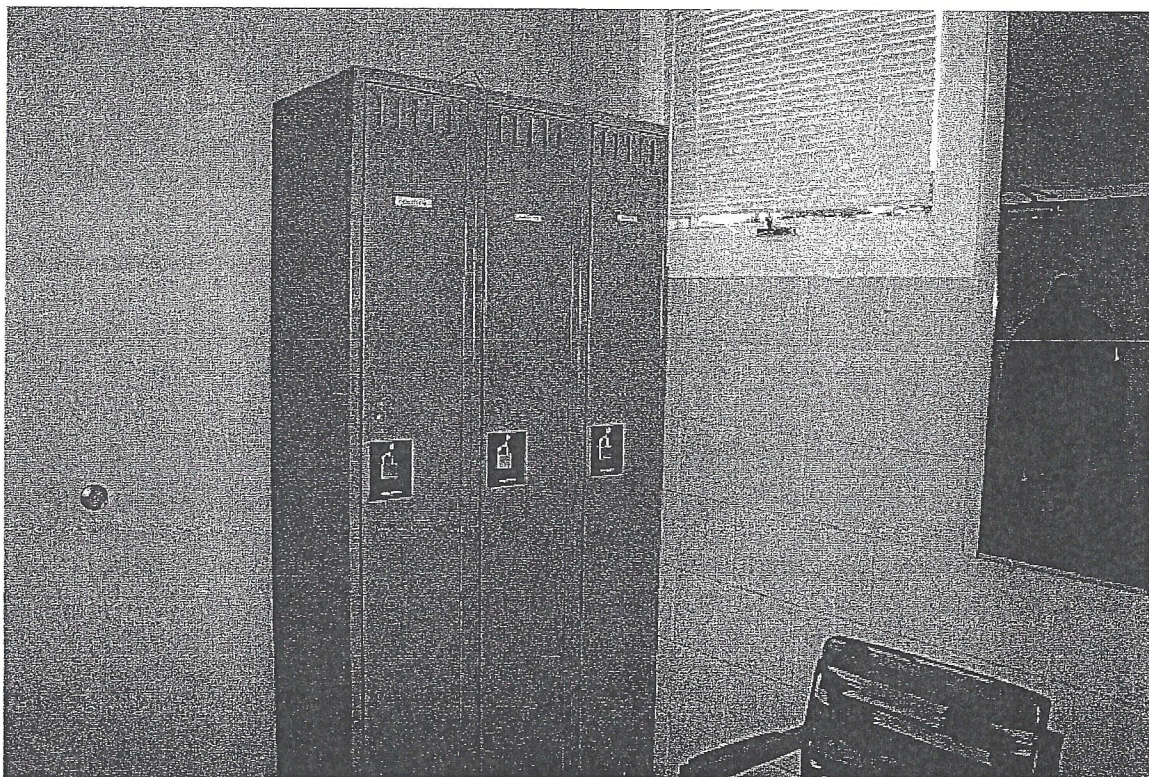
Lack of sufficient locker space for female department members.

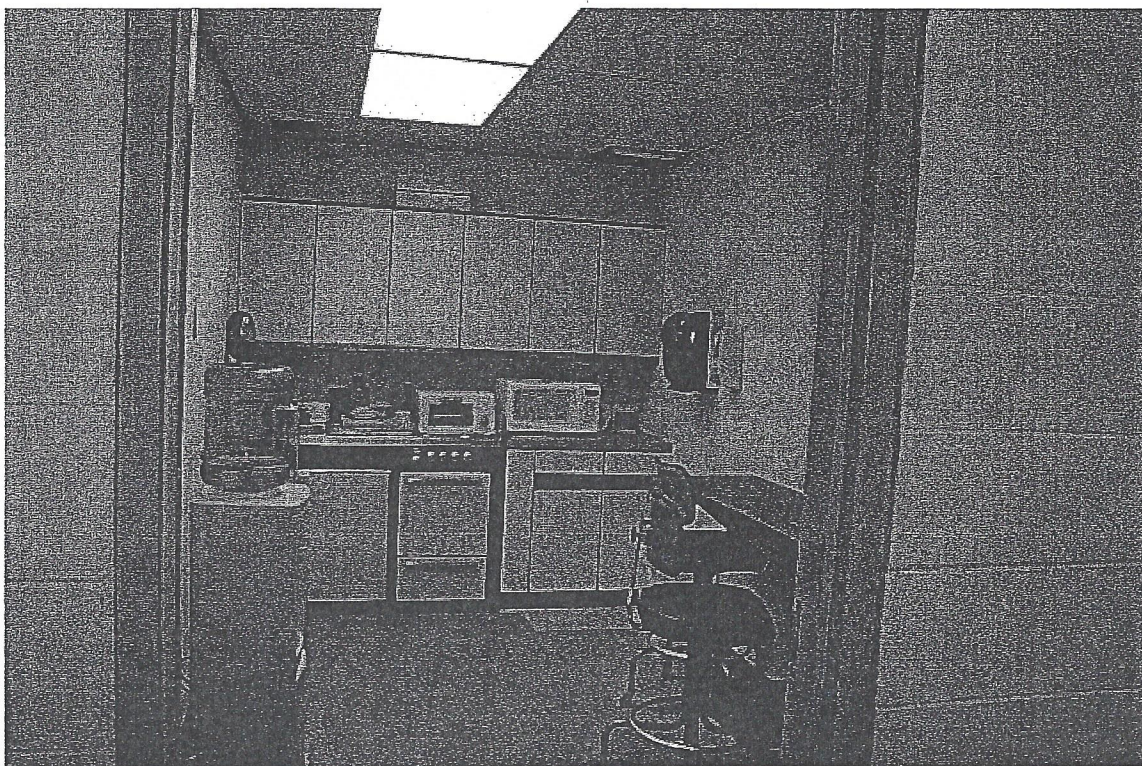
Present kitchen facilities for department personnel.

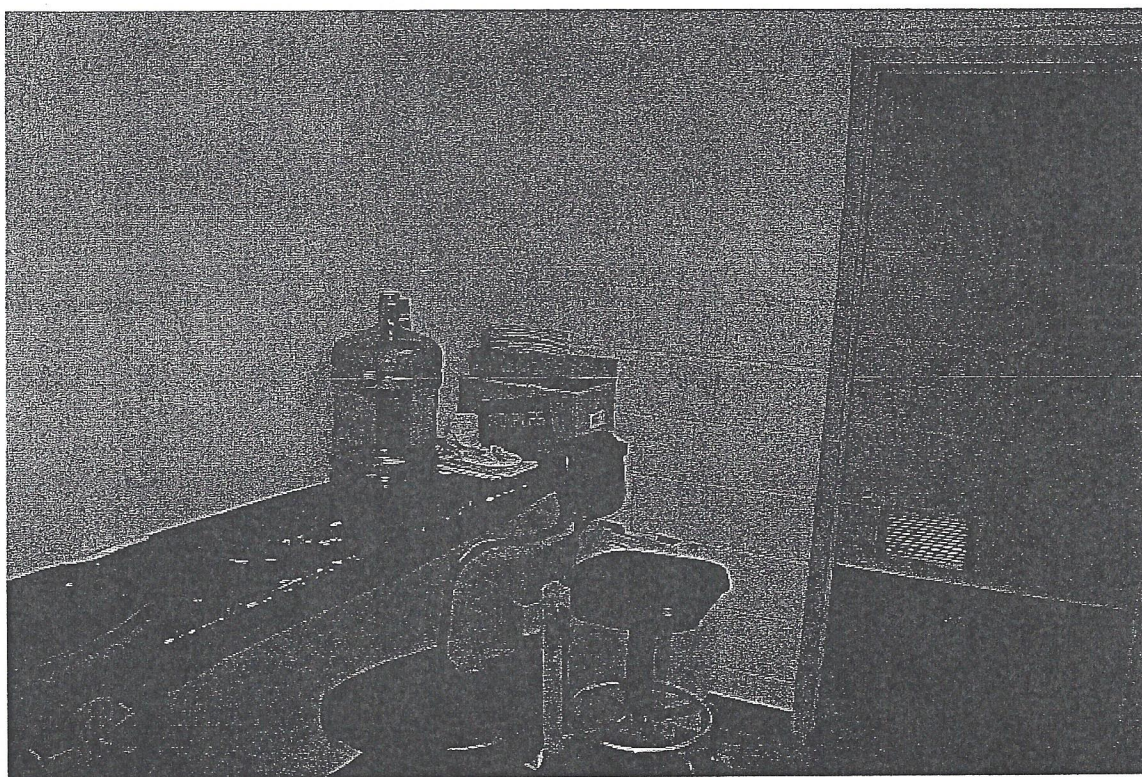
Present seating for department personnel to eat their meals and take breaks.

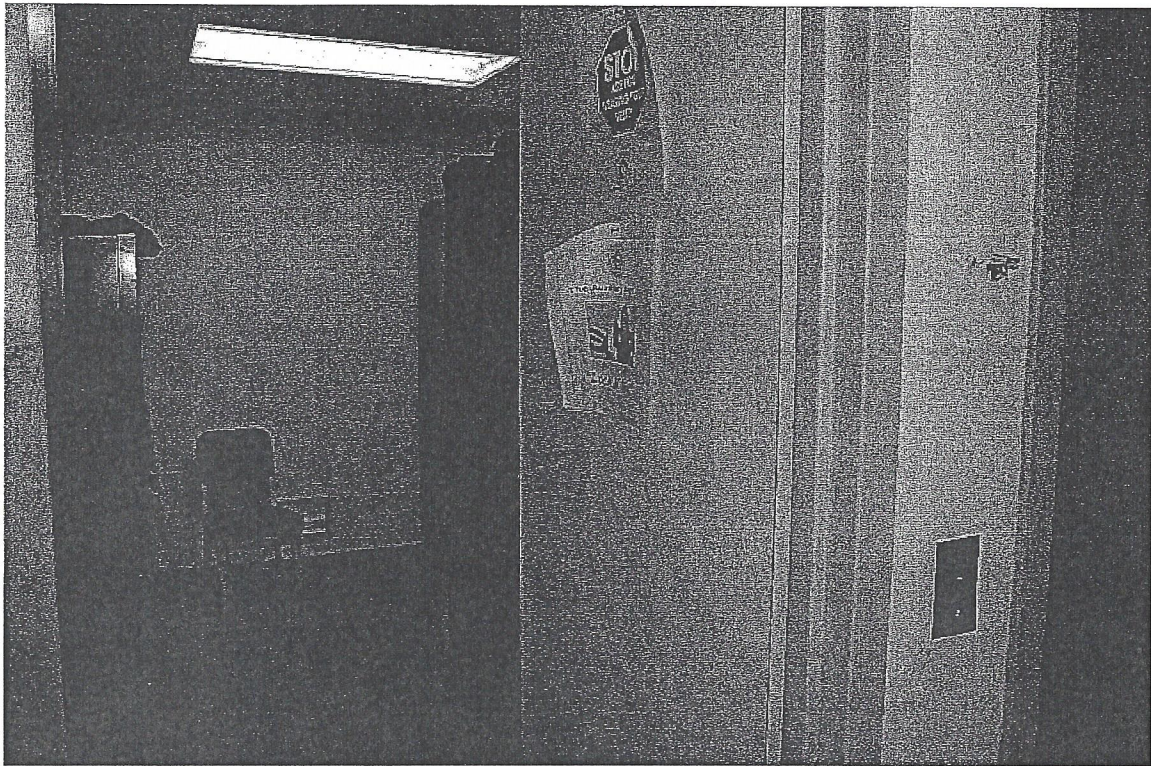
Current locker room for male department members.

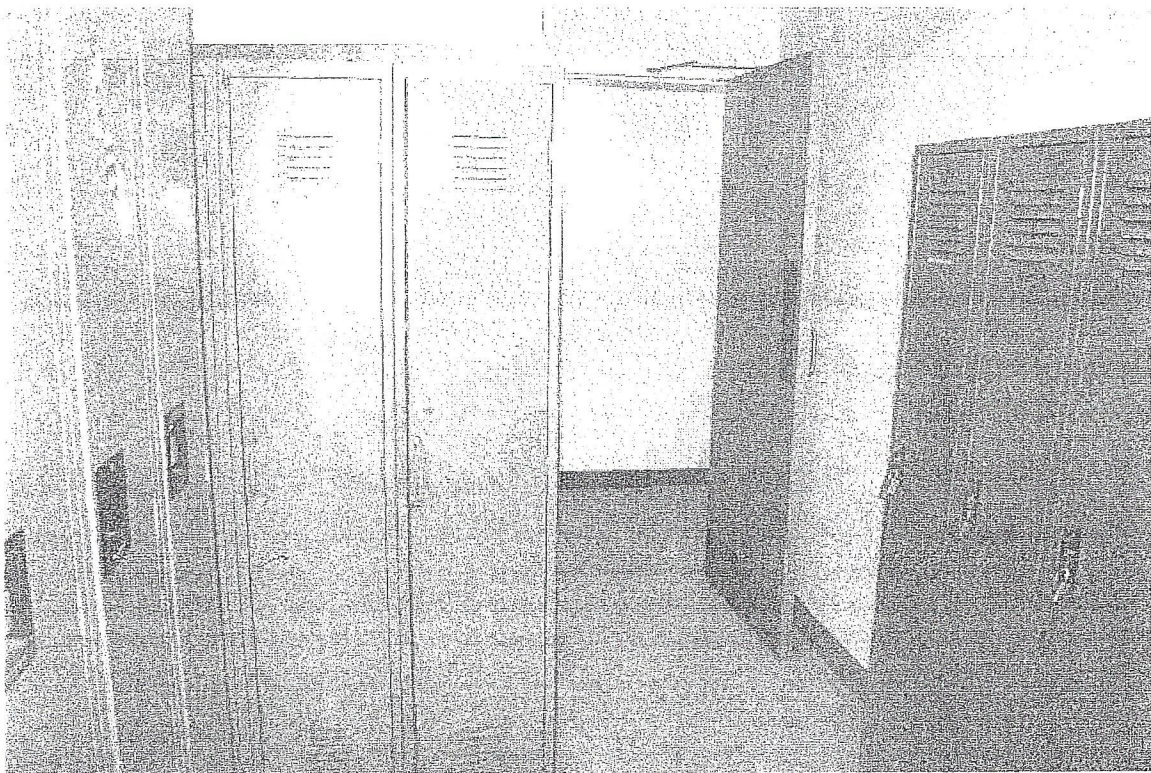
Another view of the current locker room for male department members.

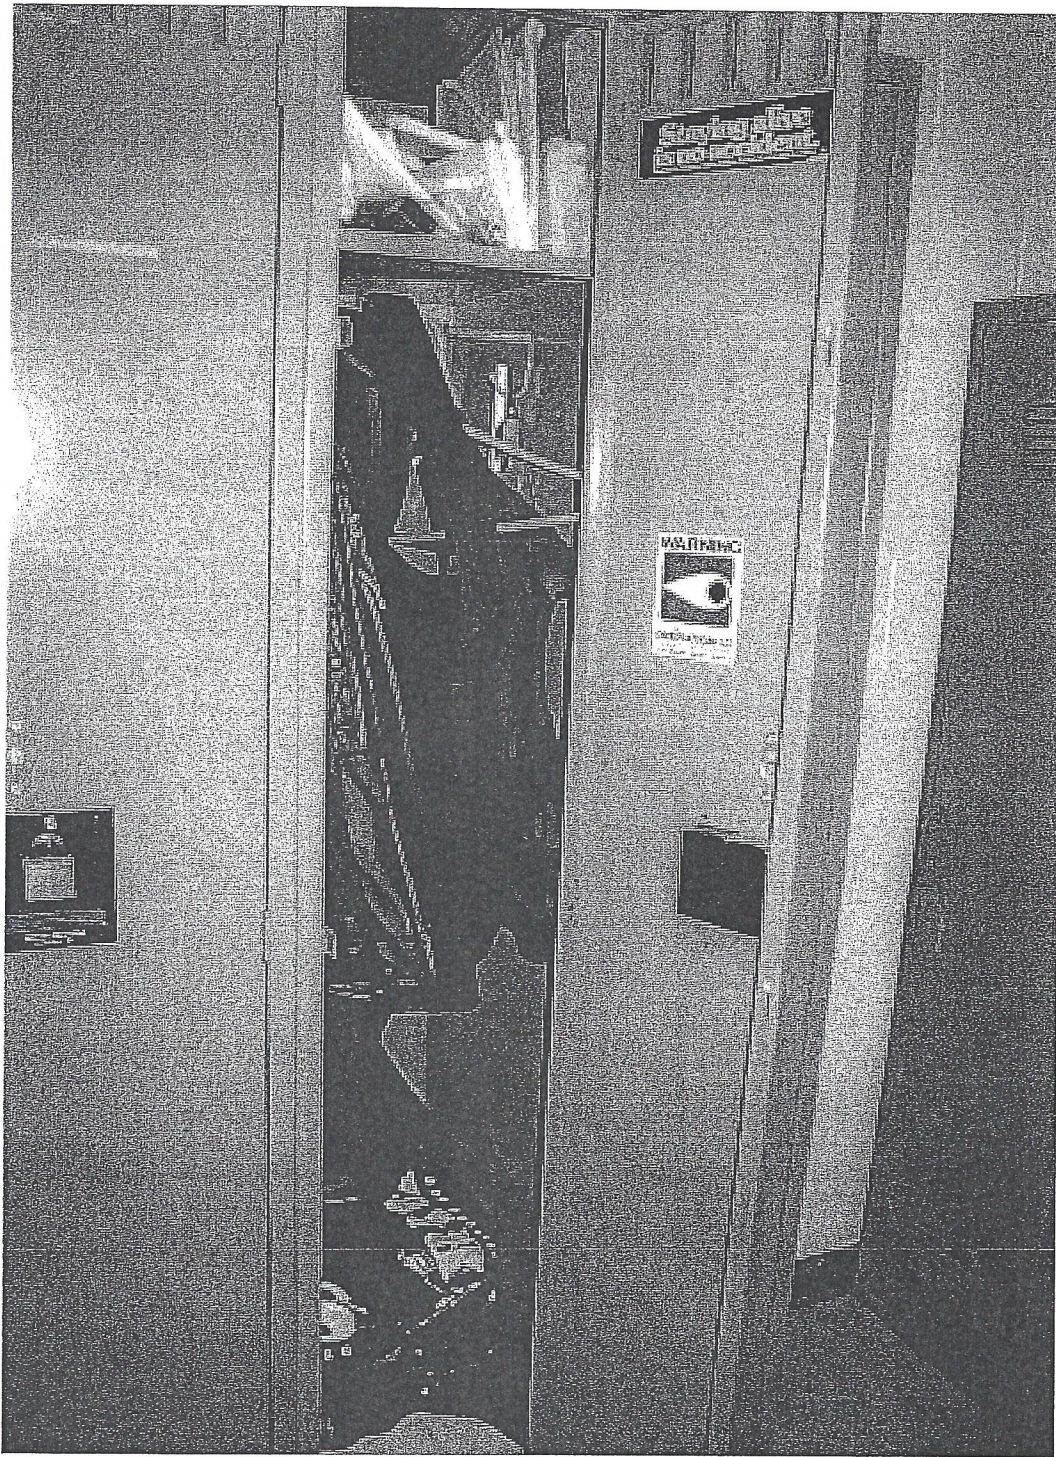
Current size of a locker in the male department member's locker room depicts how the size is not sufficient to contain an officer's equipment and clean, pressed uniforms.

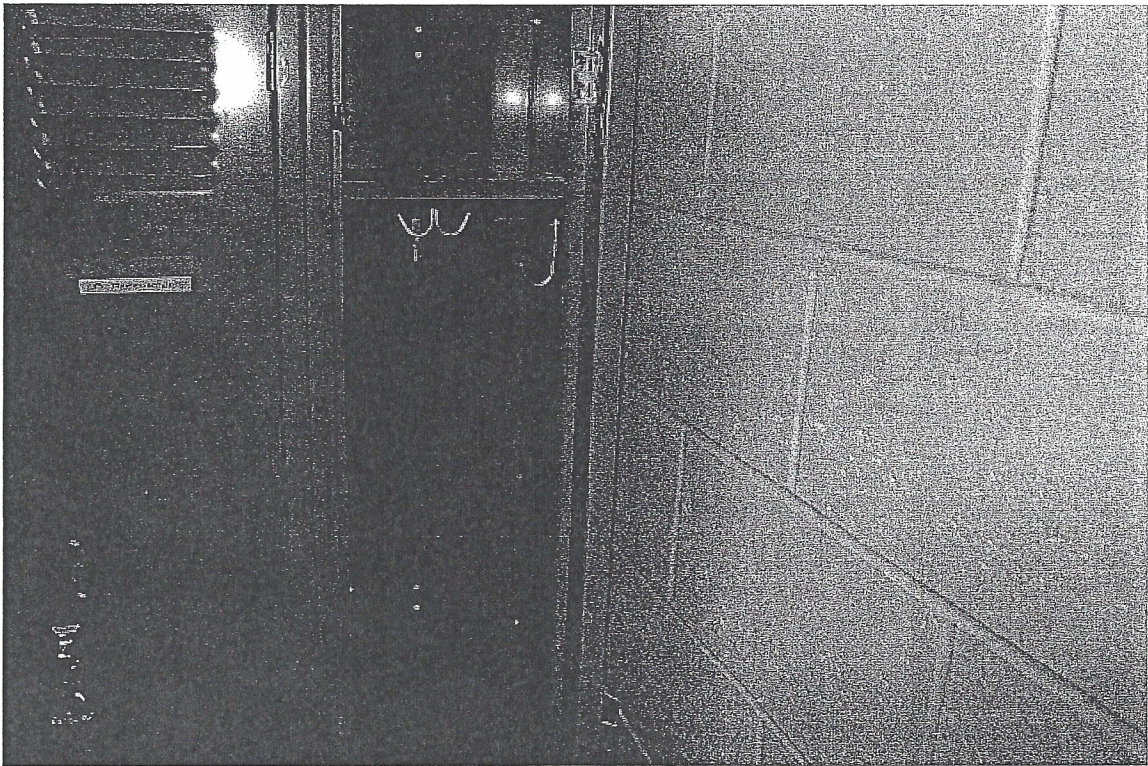
Another photo shows the size of the current lockers for officers. Compare to the cement block size on the wall to the right.

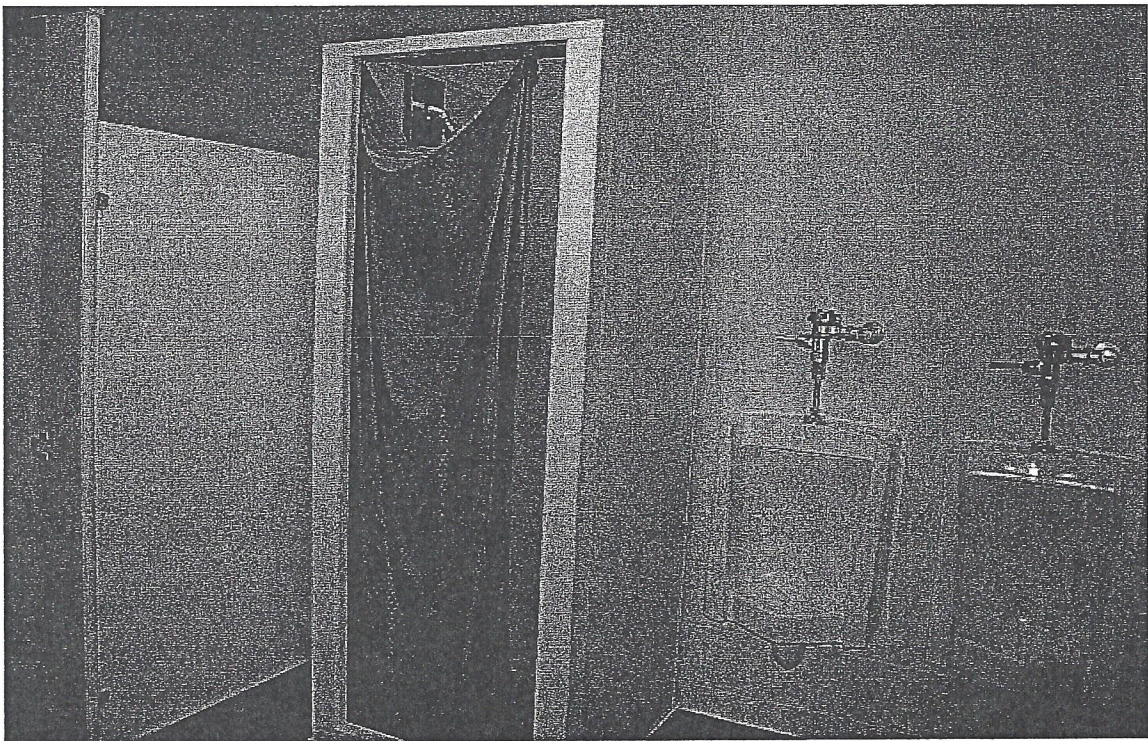
Deficient shower facilities in male bathroom. No shower facilities exist for female department members.

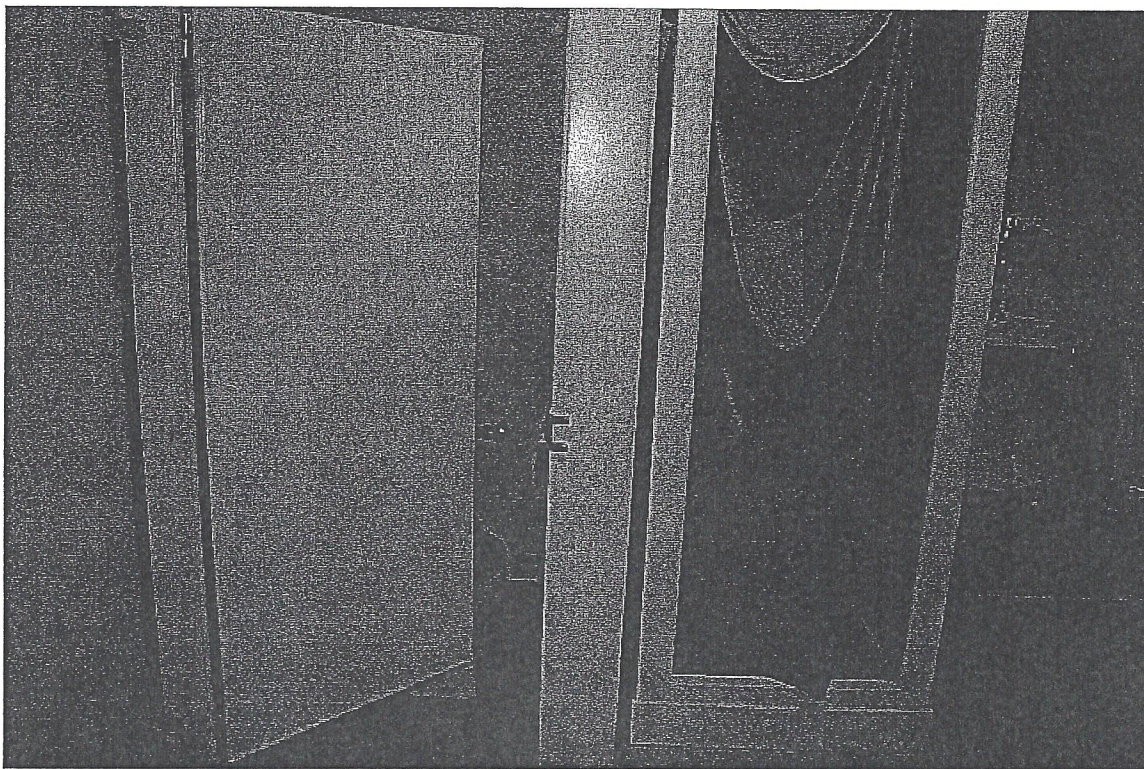
Only toilet appliance for male department members. Door hits user when trying to exit stall or user must step over and around toilet, then open door to exit.

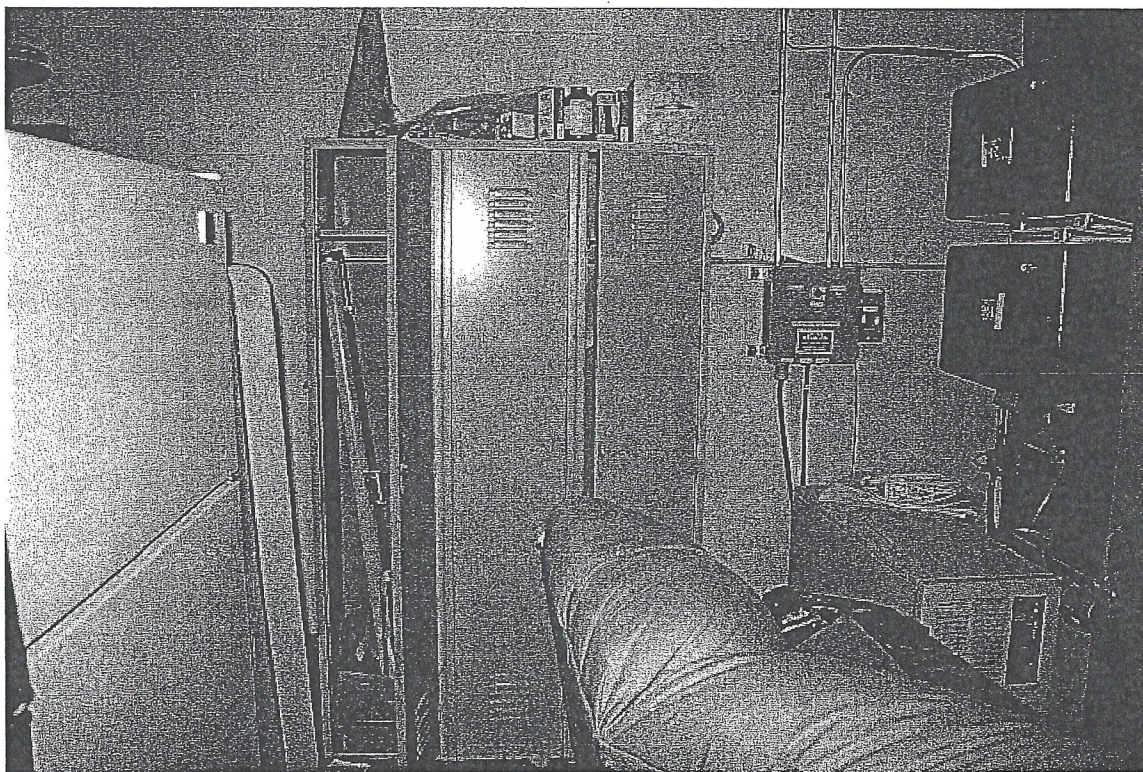
Dispatchers lockers out in the department garage, located beyond large piece of evidence.

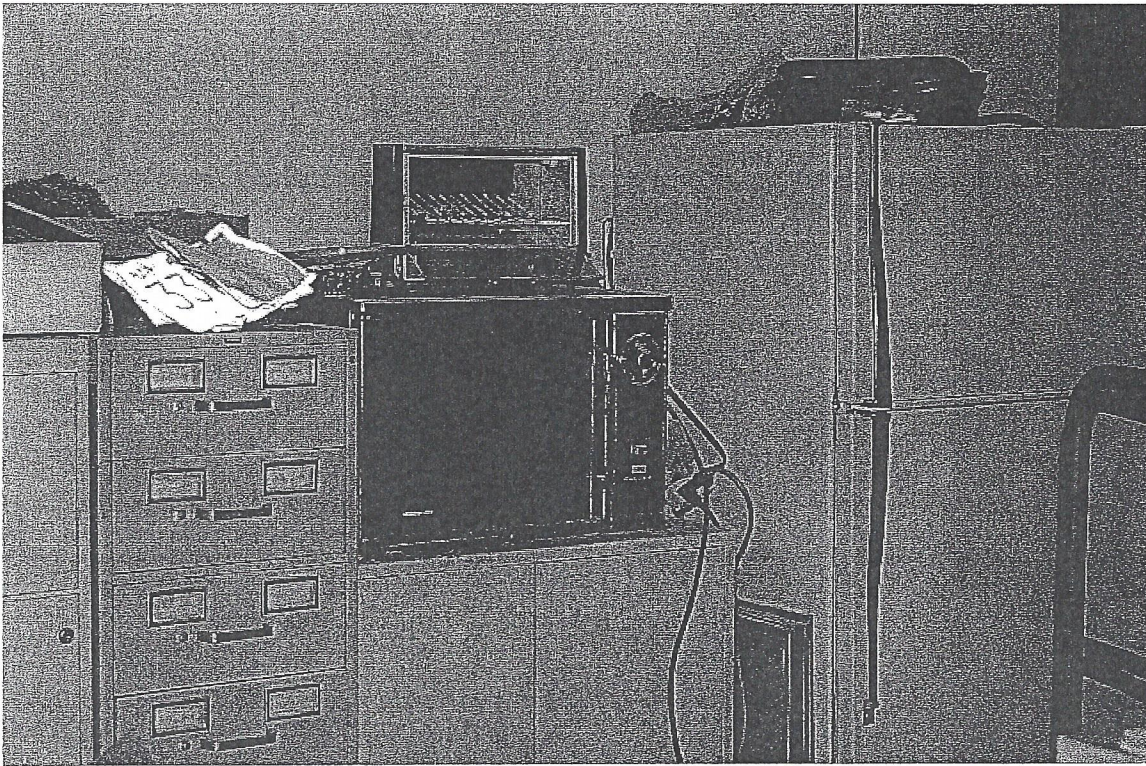
Appliances used by dispatchers to prepare meals, located in the department's garage.

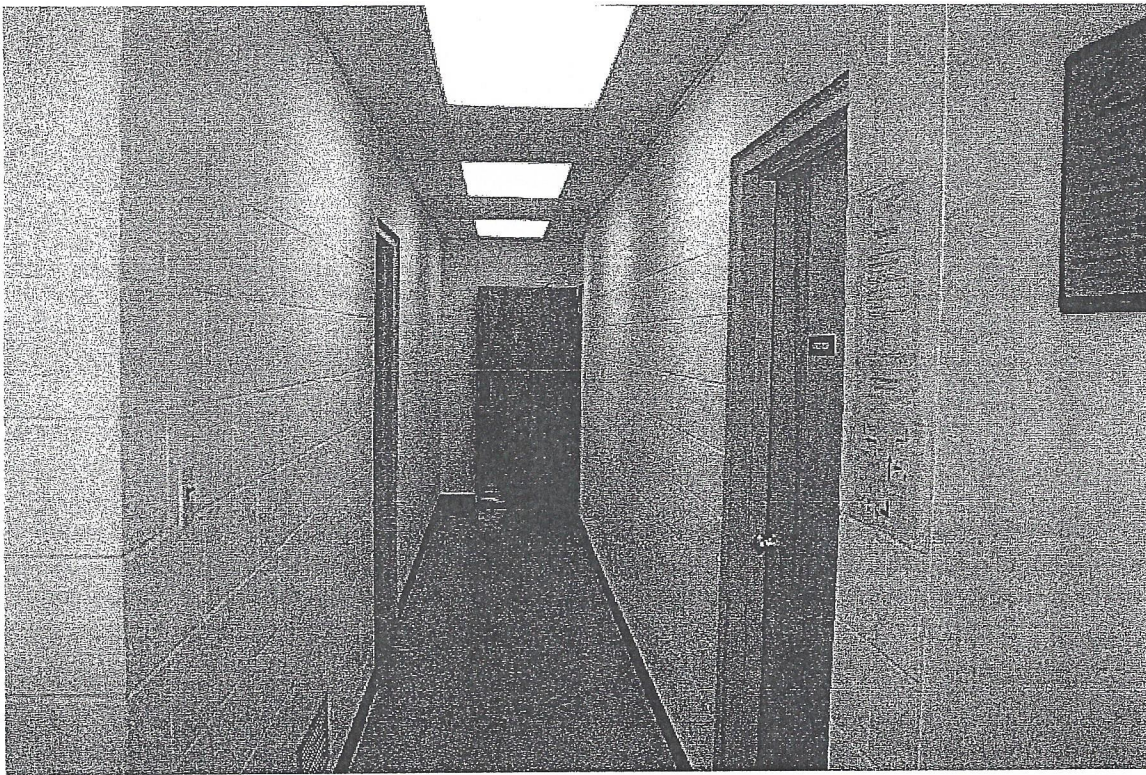
Hallway to holding facilities. No emergency exit should fire occur in this location. No fire suppression equipment, detection or alarms.

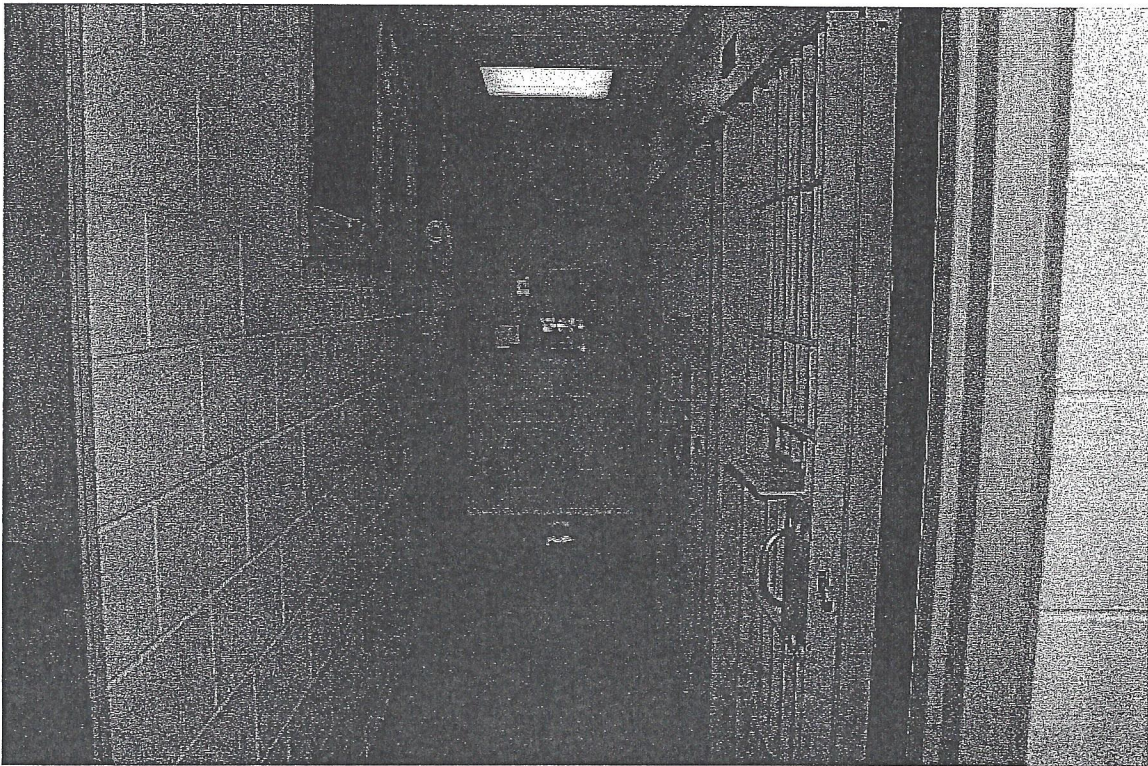
The three male holding cells. No emergency exit present. No emergency remote release on cell doors should emergency evacuation be required. No first aid box, fire suppression equipment, detection or alarms present.

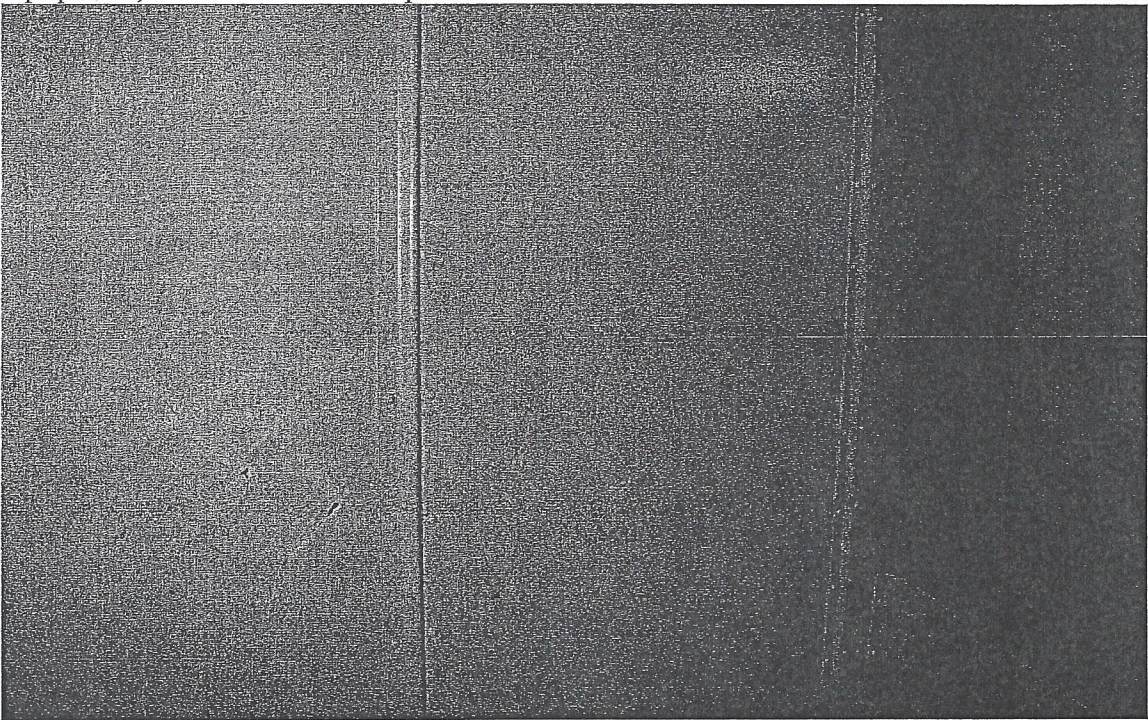
Holding cell walls permit detainee to mark or scrape name into them. State code requires cell walls, ceiling and floors be easily cleanable; painted with non-lead, fire retardant paint. No drains on floors to facilitate cleaning for bio-hazards.

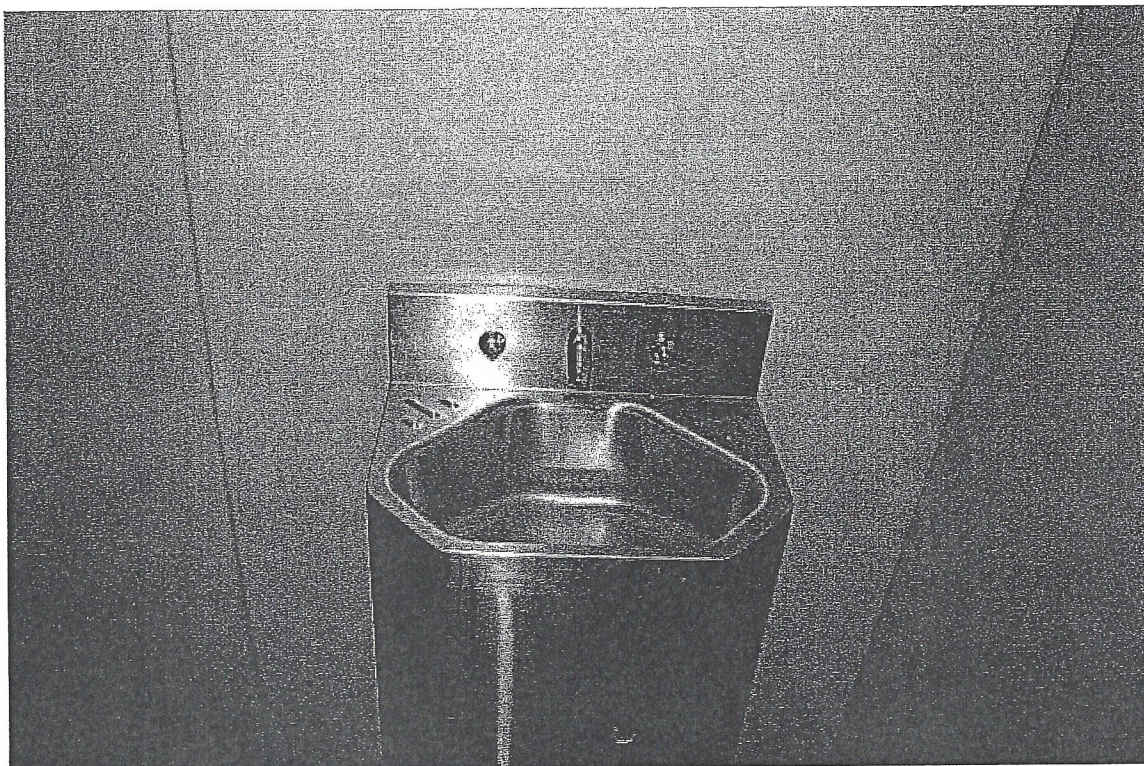
This type of toilet appliance contains a slit in the sink spouts that poses a risk to those contemplating suicide.

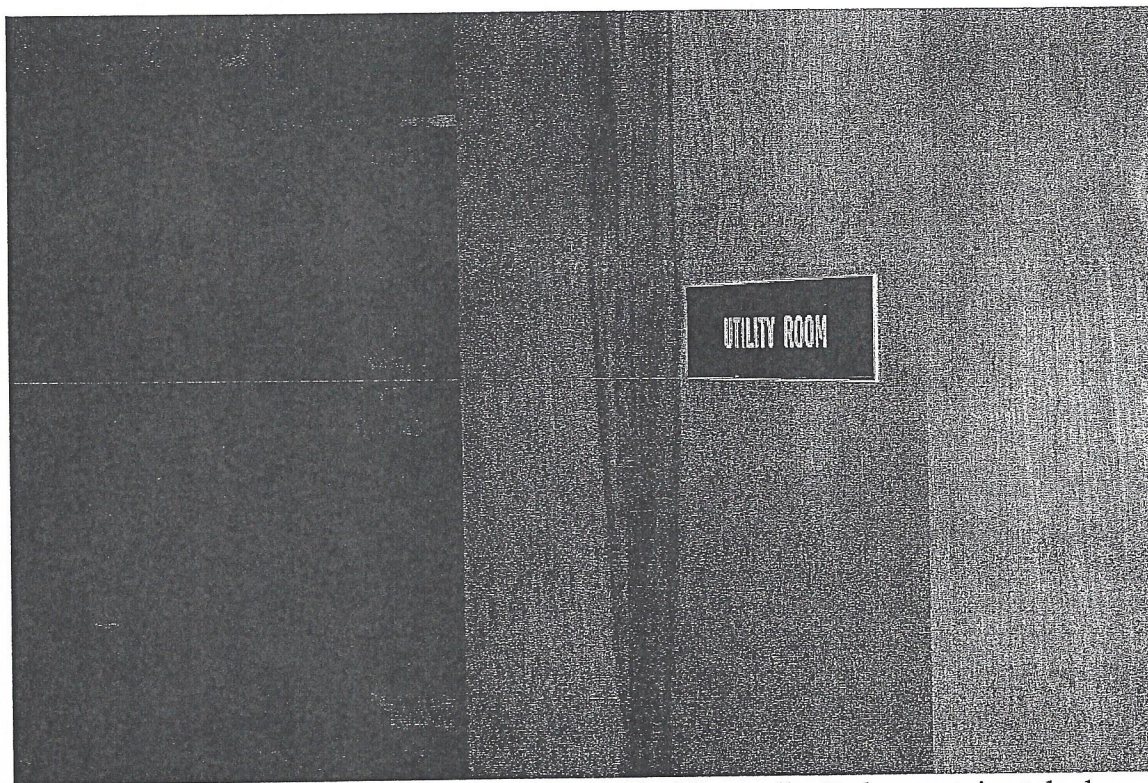
This room contains the internal plumbing for the holding cells. It also contains telephone and various utilities infrastructure, including the 911 system, telephones, computer equipment and is used for assorted storage.

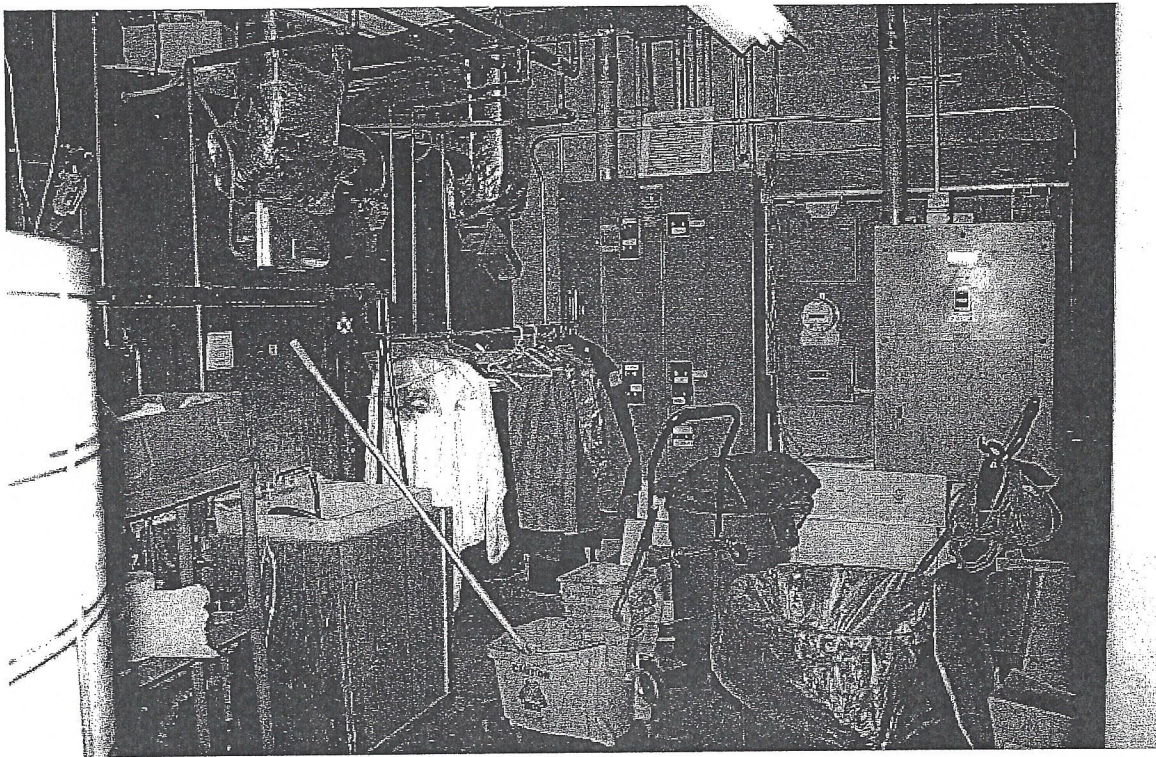
This room contains water, janitor's equipment and cleaning supplies. Also visible are uniforms and clothing on storage rack. Against the far wall are various electrical panels that power the station and its equipment.

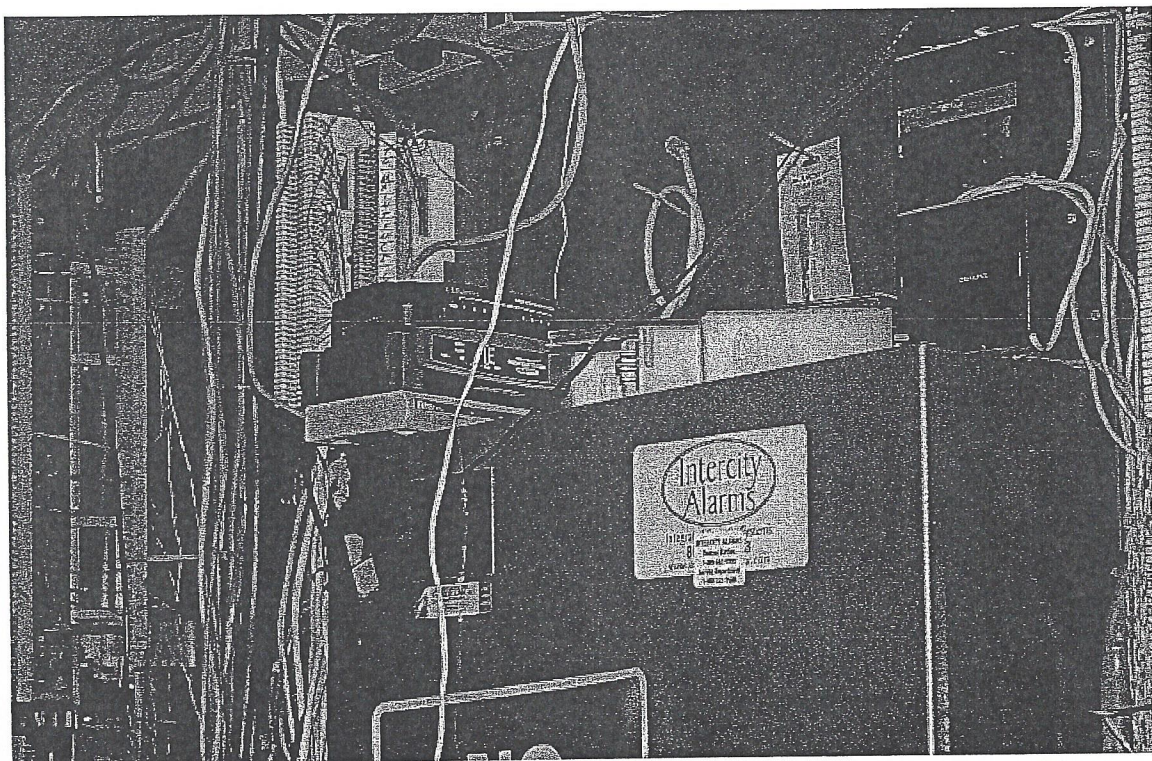
Computer switching modems, the alarm panel and connecting telephone lines, and exposed wires that are connected to different sources of equipment.

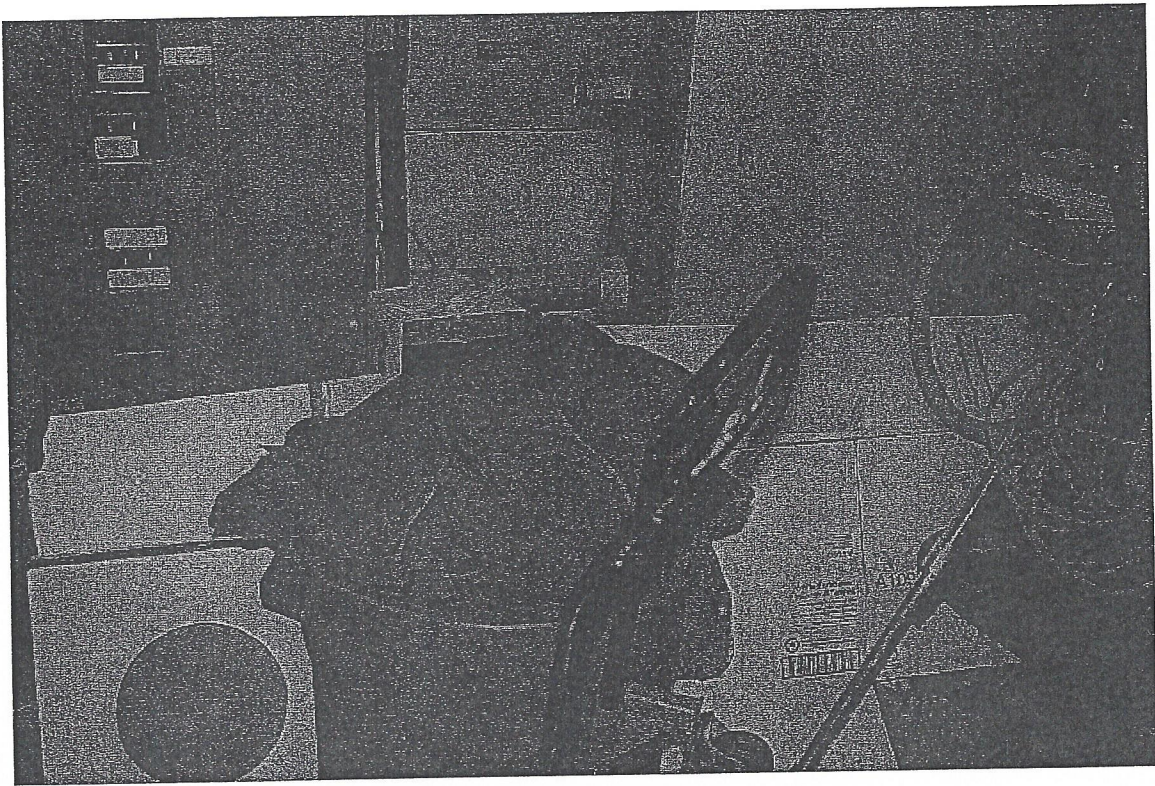
Assorted equipment and other stored items unsecured electrical and other utility panels.

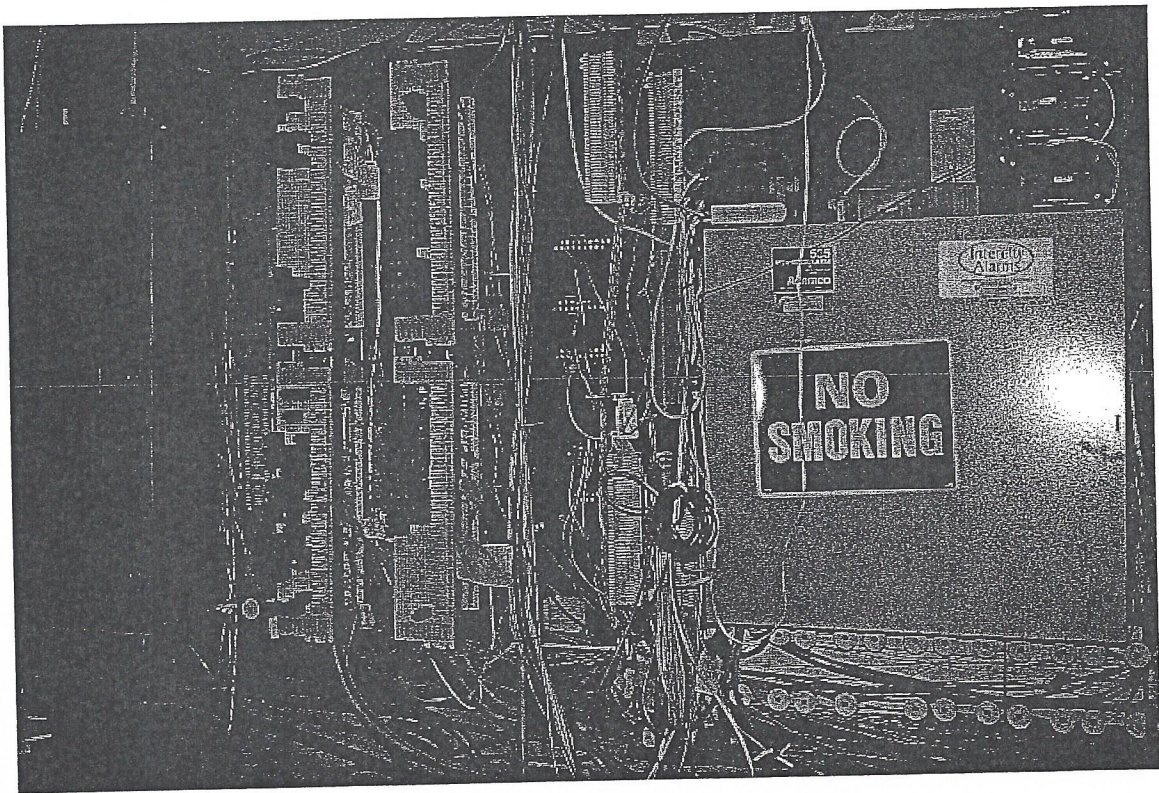
More of the department's critical infrastructure exposed without being in a secure, closed environment, susceptible to human error or more serious events.

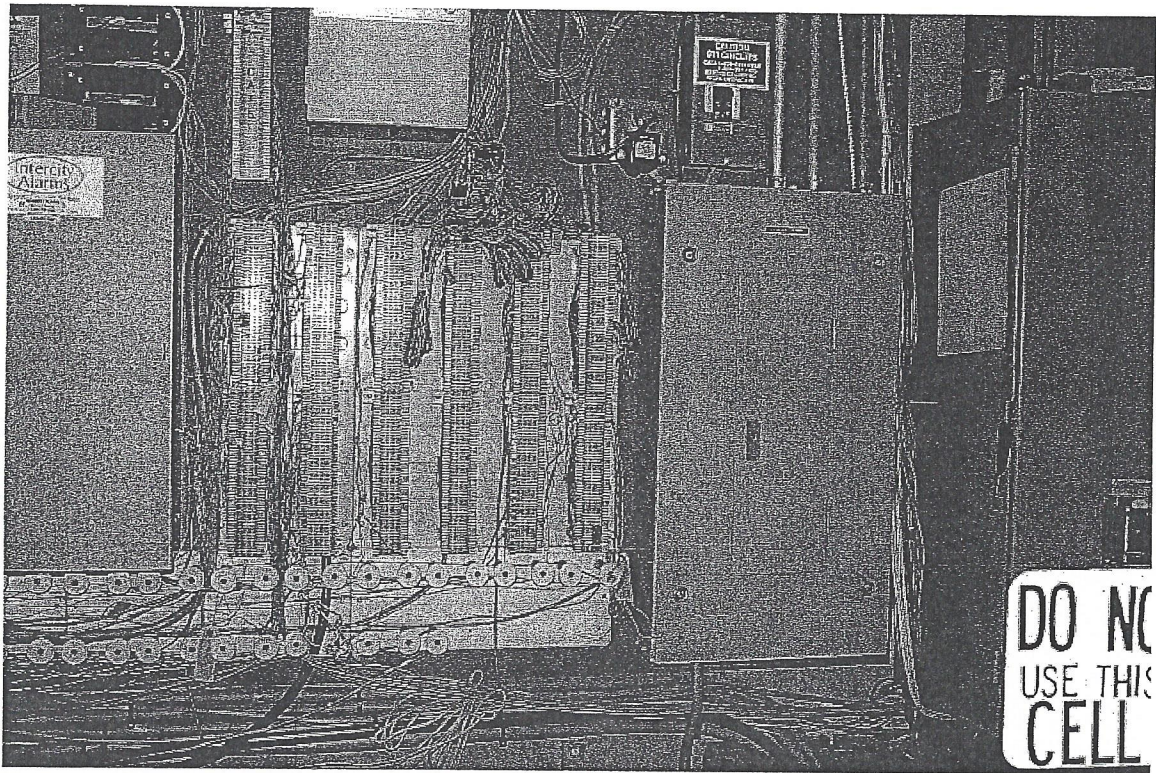
More unprotected critical infrastructure, including various alarms and 911 connections.
