POLICE STATION NEEDS ASSESSMENT STUDY FOR

**CARVER
POLICE DEPARTMENT**

5. LIST of PRESENT CARVER POLICE STATION DEFICENCIES and EXISTING CONDITIONS

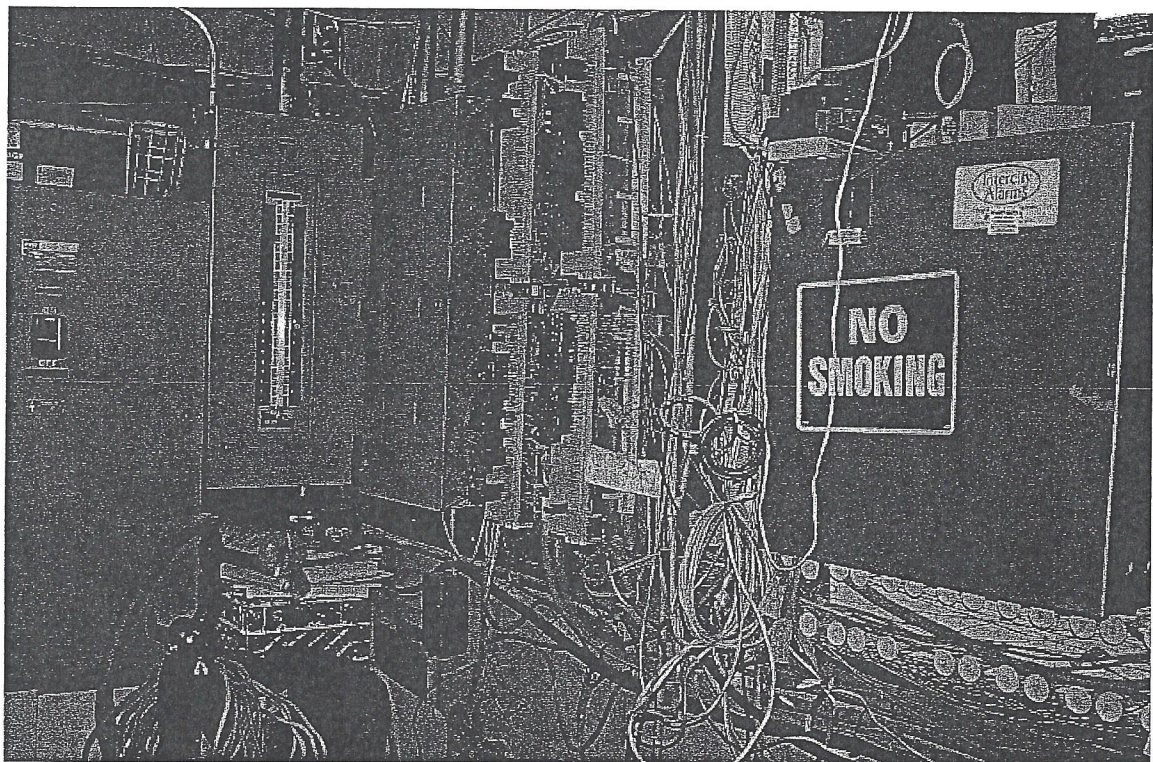
Equipment and miscellaneous storage on left with unsecured infrastructure.

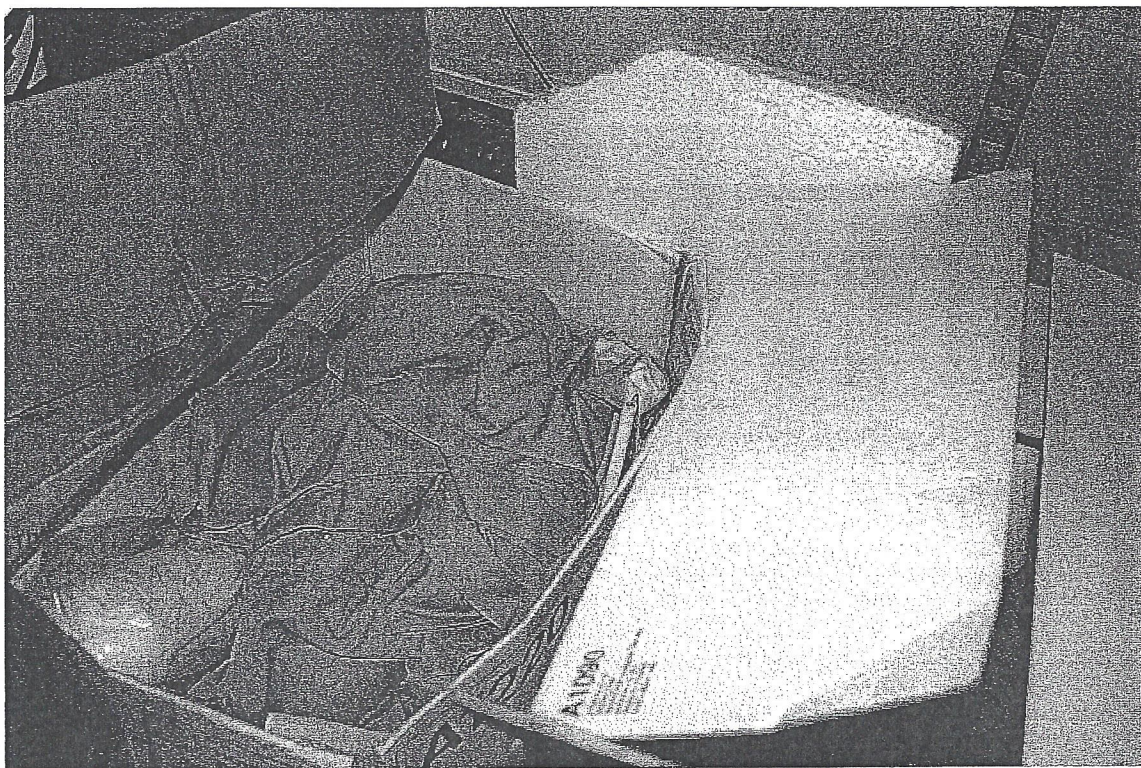
This utility room is also used for miscellaneous storage out of necessity.

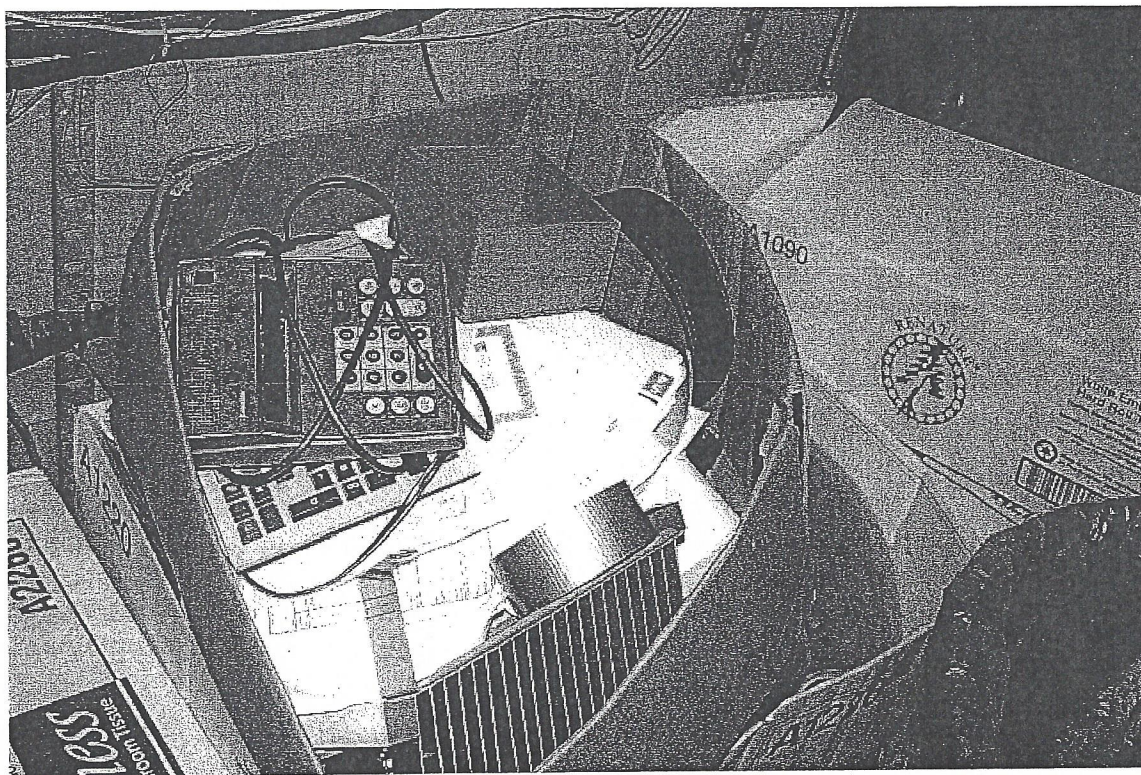
More assorted storage in the utility room.

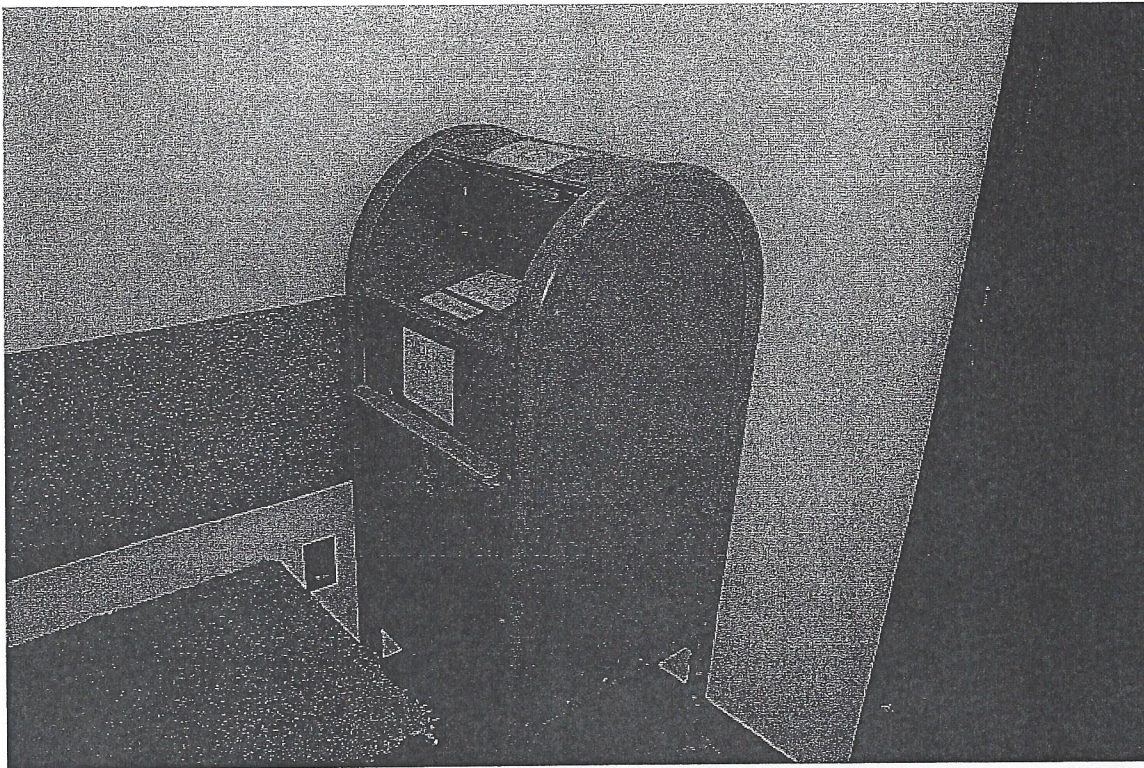
Current temporary evidence drop where officers deposit evidence until it can be transferred to the secured evidence locker. Cannot be used if liquid or large items of evidence.

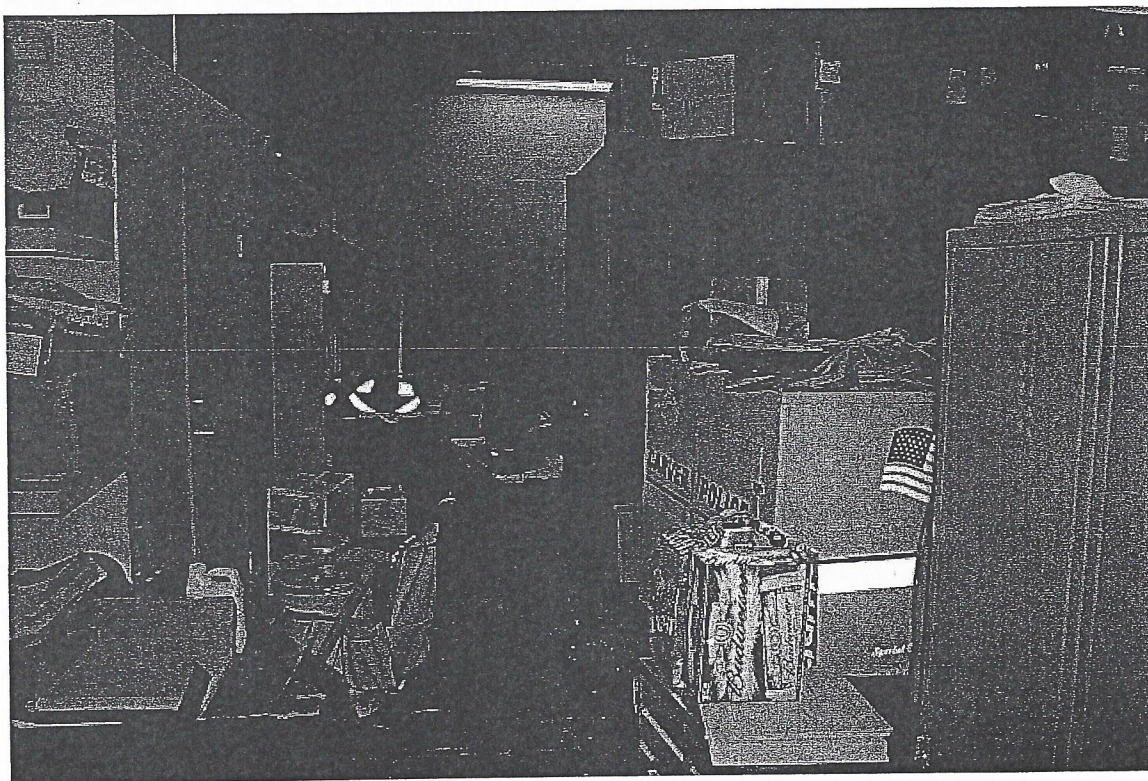
The leased gray storage container is contains uncatalogued and large pieces of evidence.

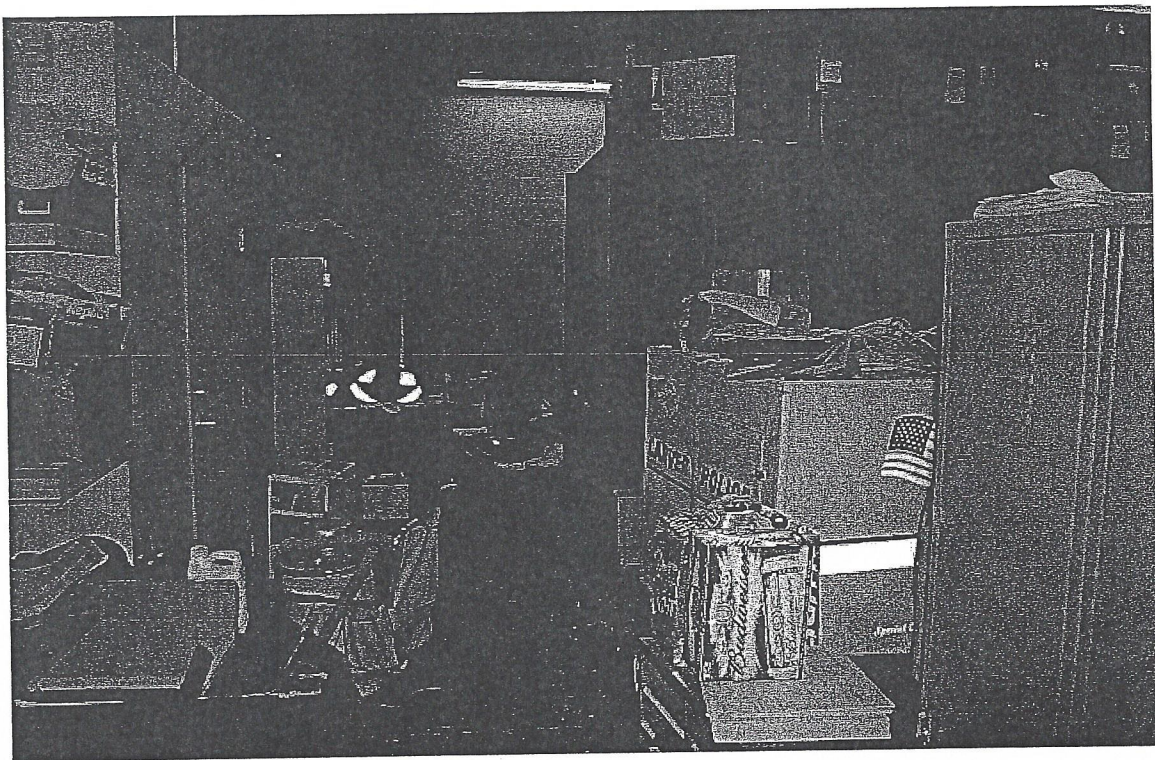
Overview of the garage area, that was originally used to garage ambulances and later used as a sallyport to deliver and upload prisoners.

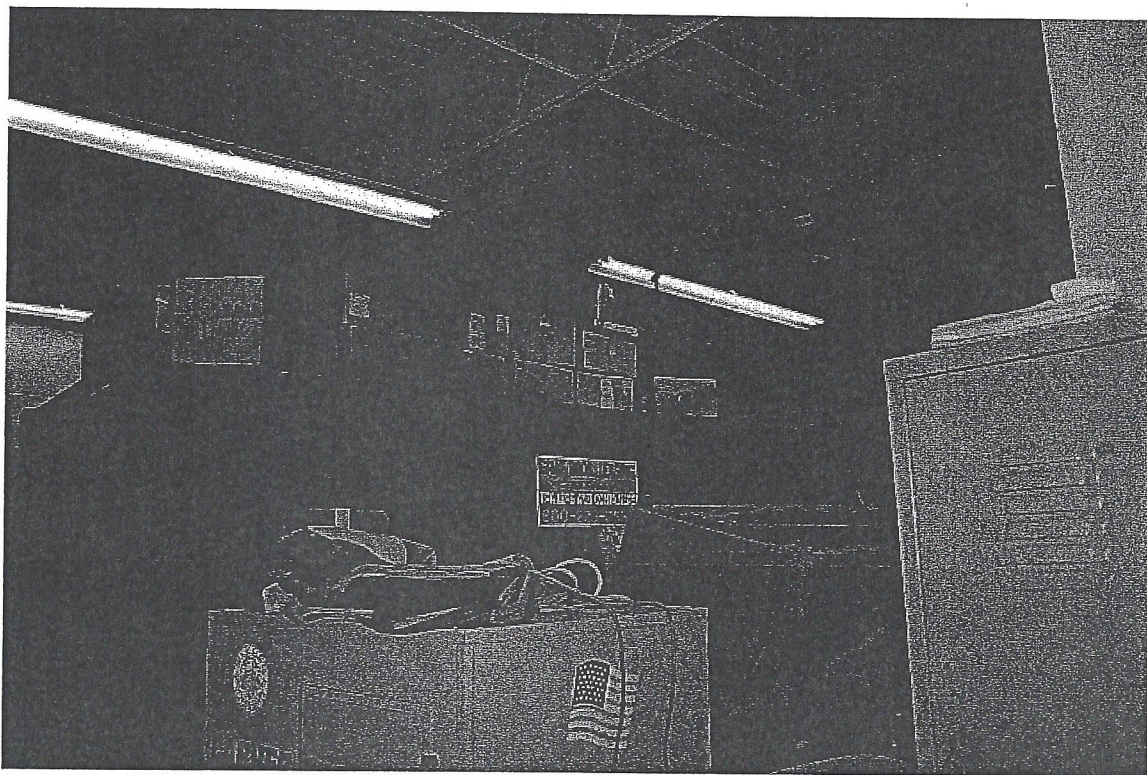
Computer boxes and other equipment stored on the storage box in the garage.

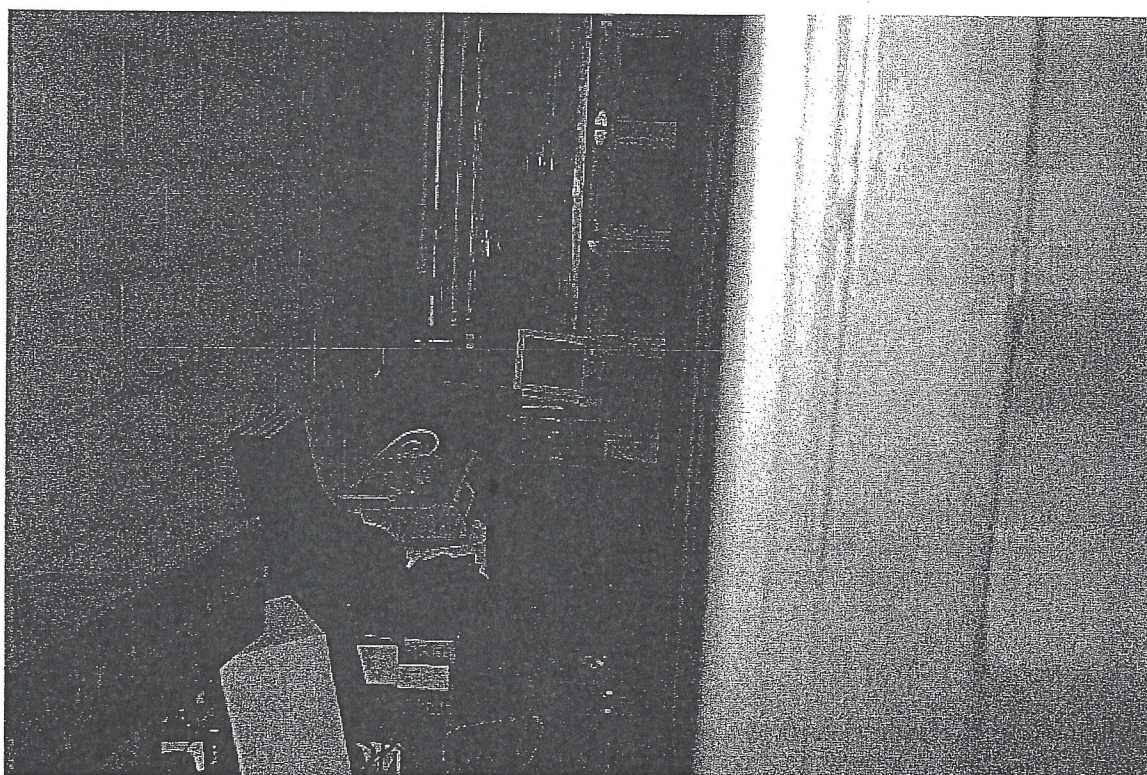
All space is currently utilized. Here used computer equipment is stored until disposed of.

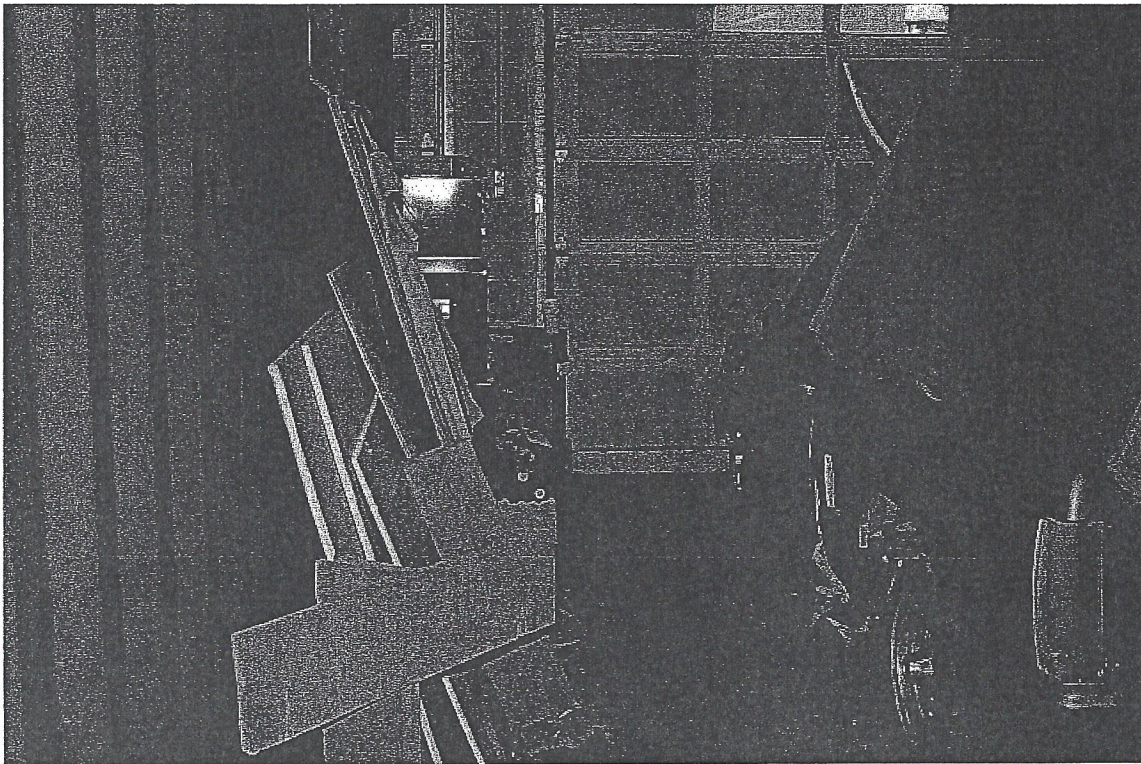
One garage bay a seized pick up truck and couch, both seized as evidence. This garage bay was utilized as a sallyport or prisoner drop off but must securely house this evidence.

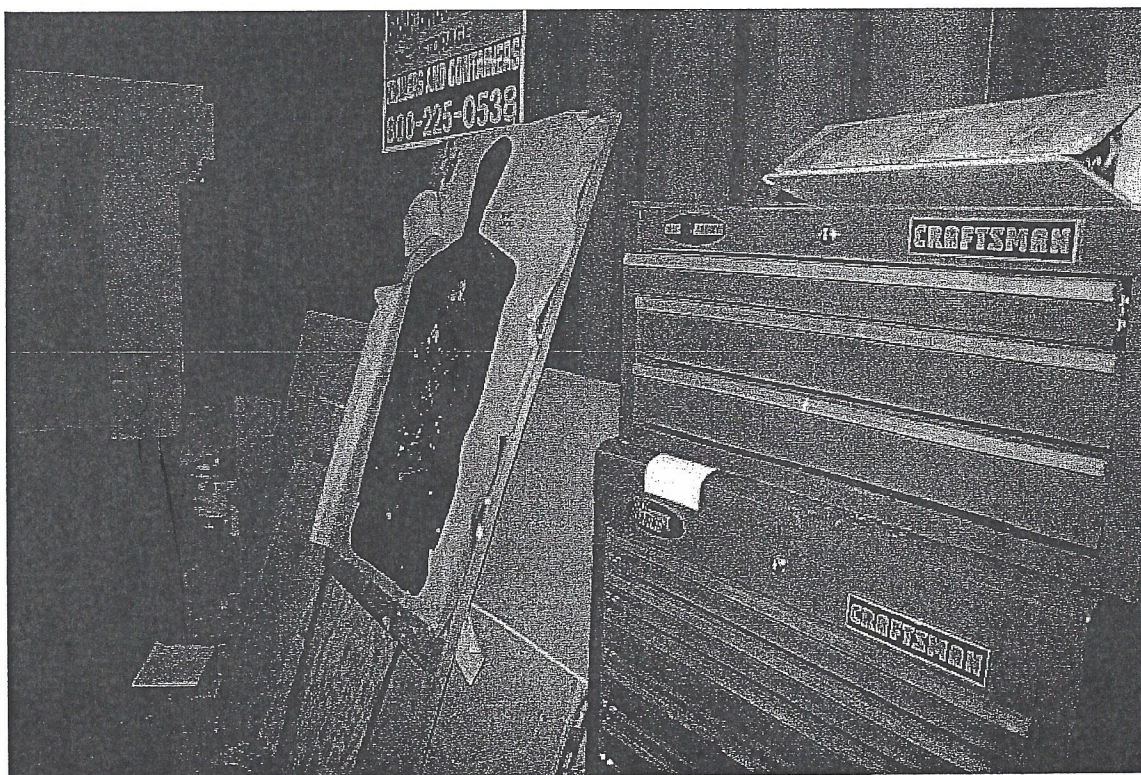
Large evidence and department firearms supplies stored in the sallyport.

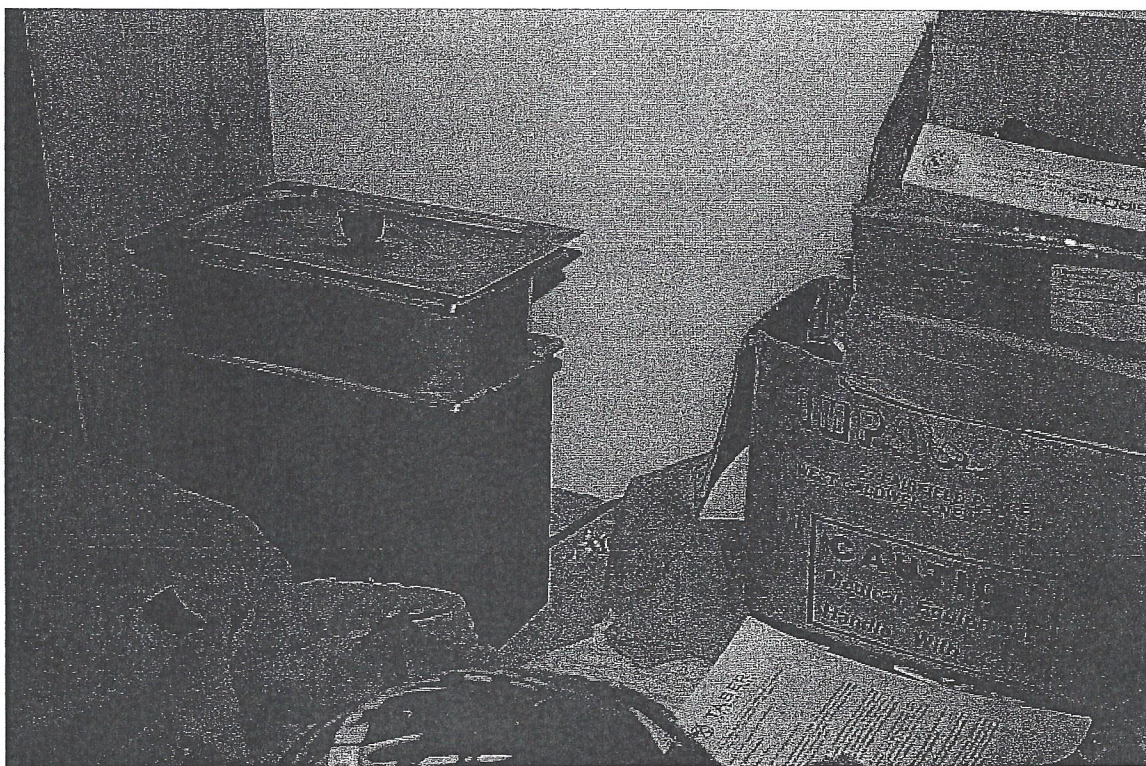
Lack of secure firearms maintenance area.

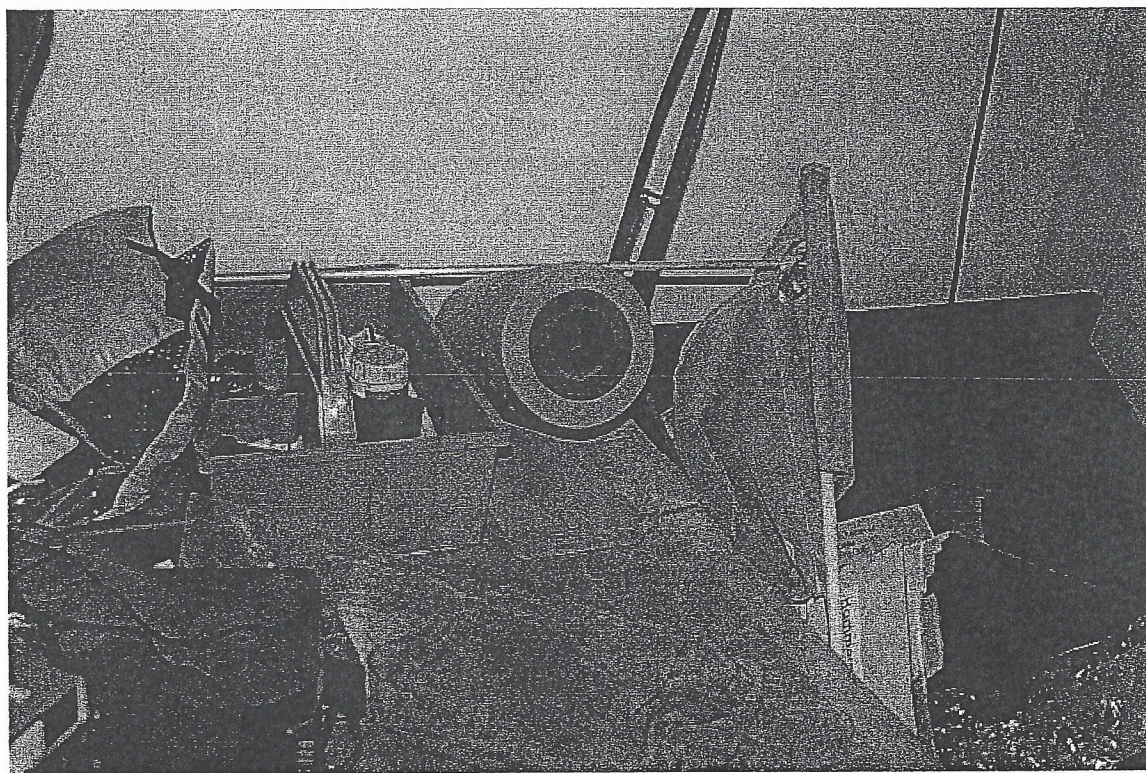
Inadequate area used to maintain firearms and related equipment.

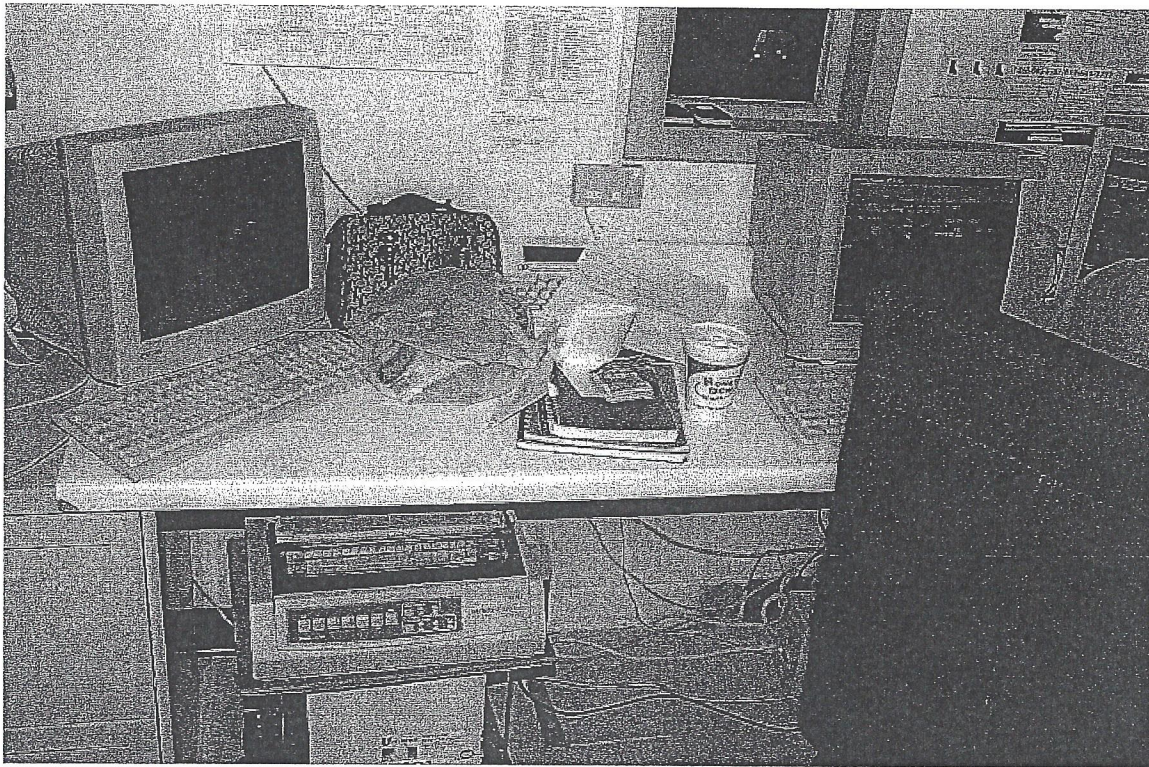
This area doubles as a workspace for dispatchers and also where they eat their meals.

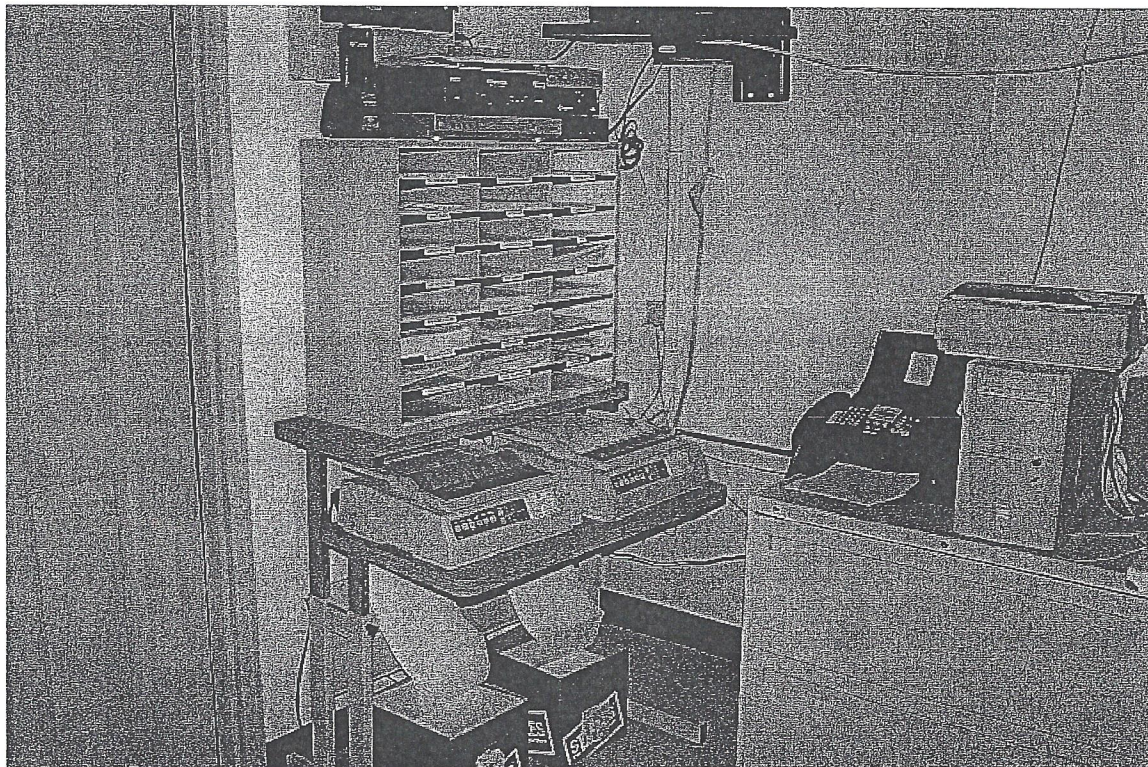
The current design causes background noises from office machines picked up and overheard on radio transmissions. There is no security or privacy for member's mail.

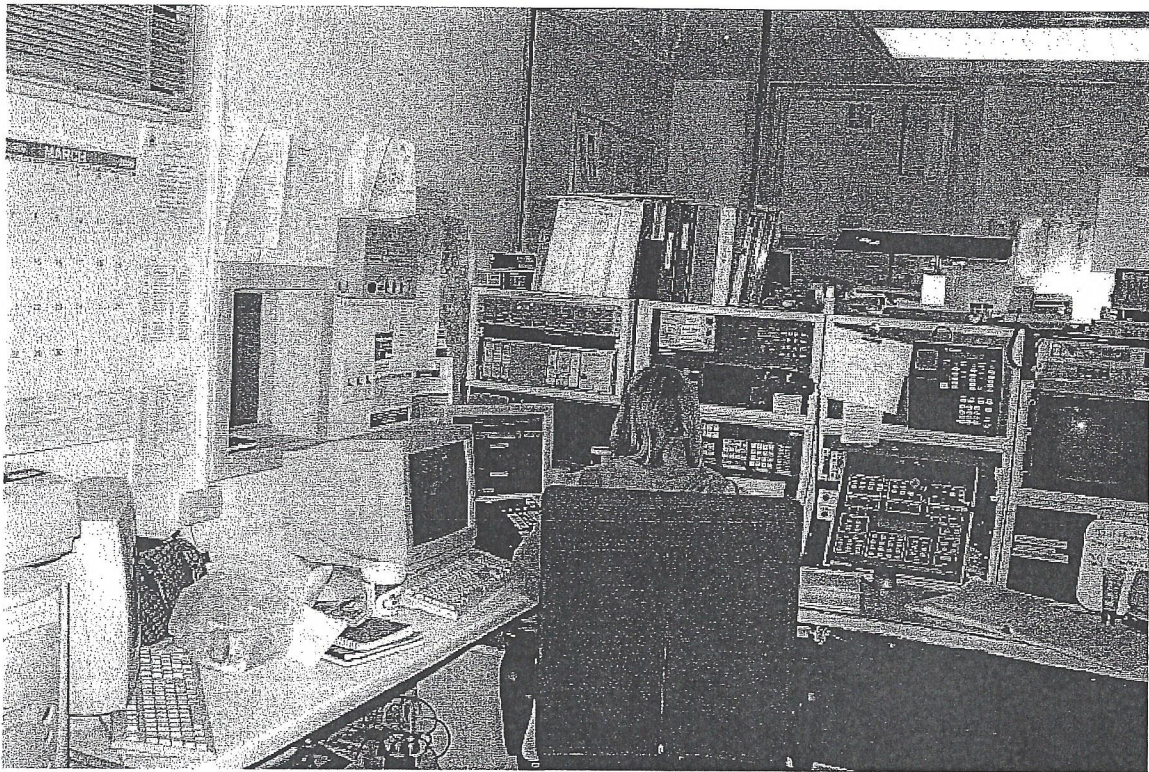
Various add-on equipment over time has created an unprofessional workplace area.

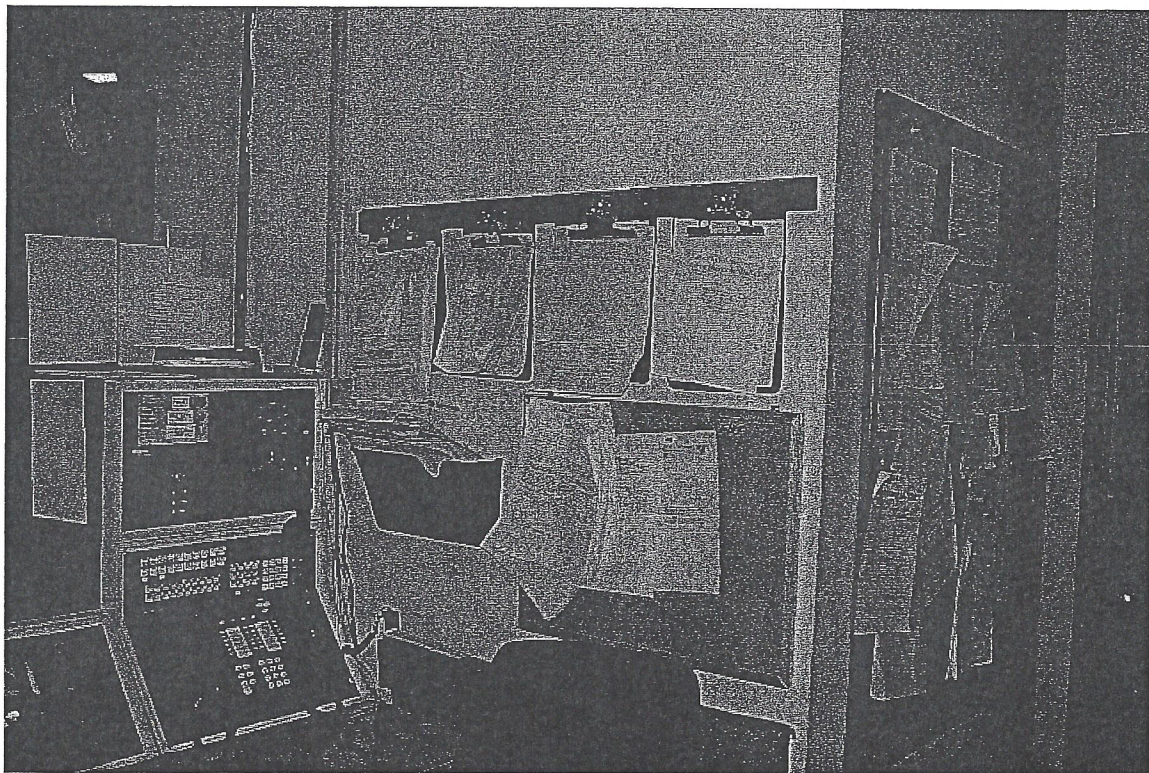
Crucial information on clipboards stored where public may possibly read.

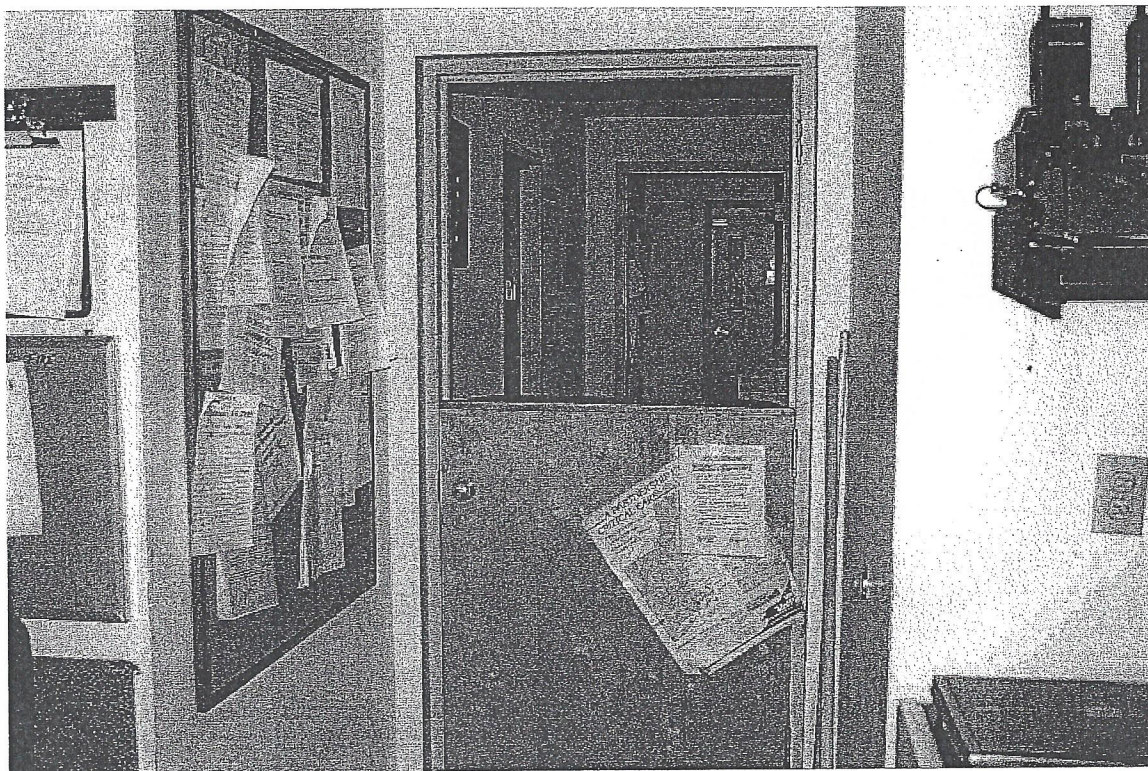
Area where communications dispatchers interface with officers. Note portable radios stored in the upper right due to inability to store in roll call room.

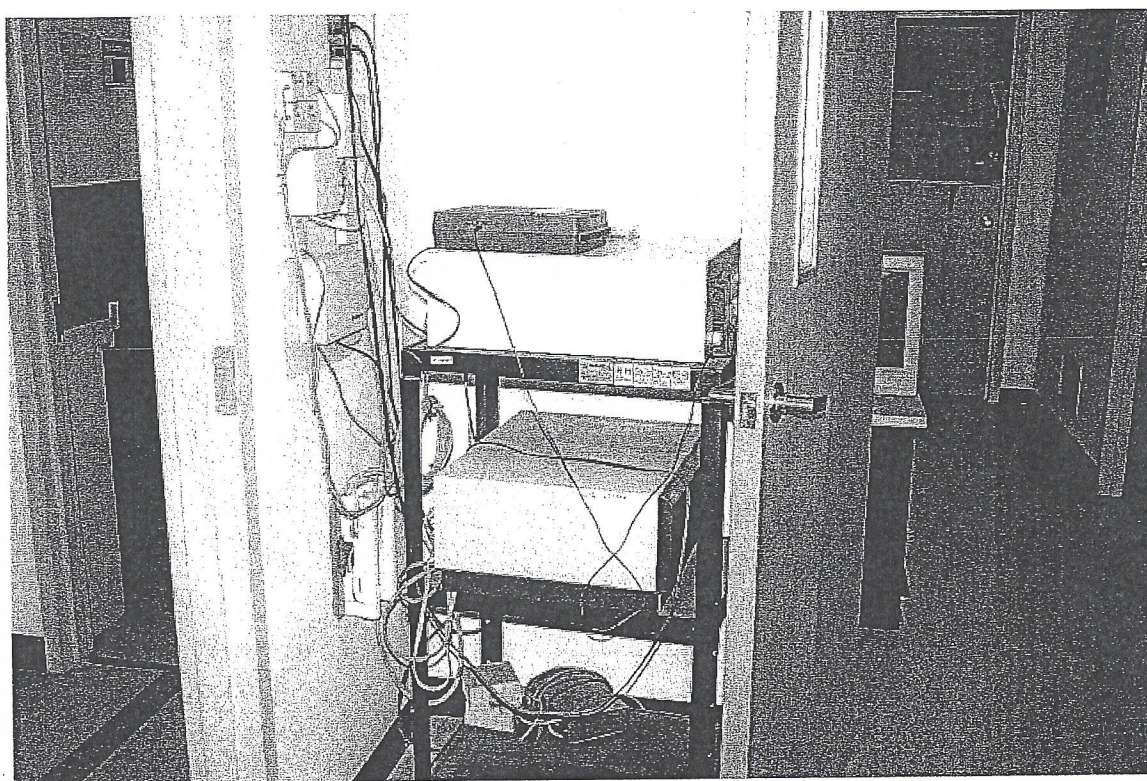
This equipment permits recordings of all radio and telephone traffic and should be secure. Dispatchers require but do not have equipment to immediate access to playback of both.

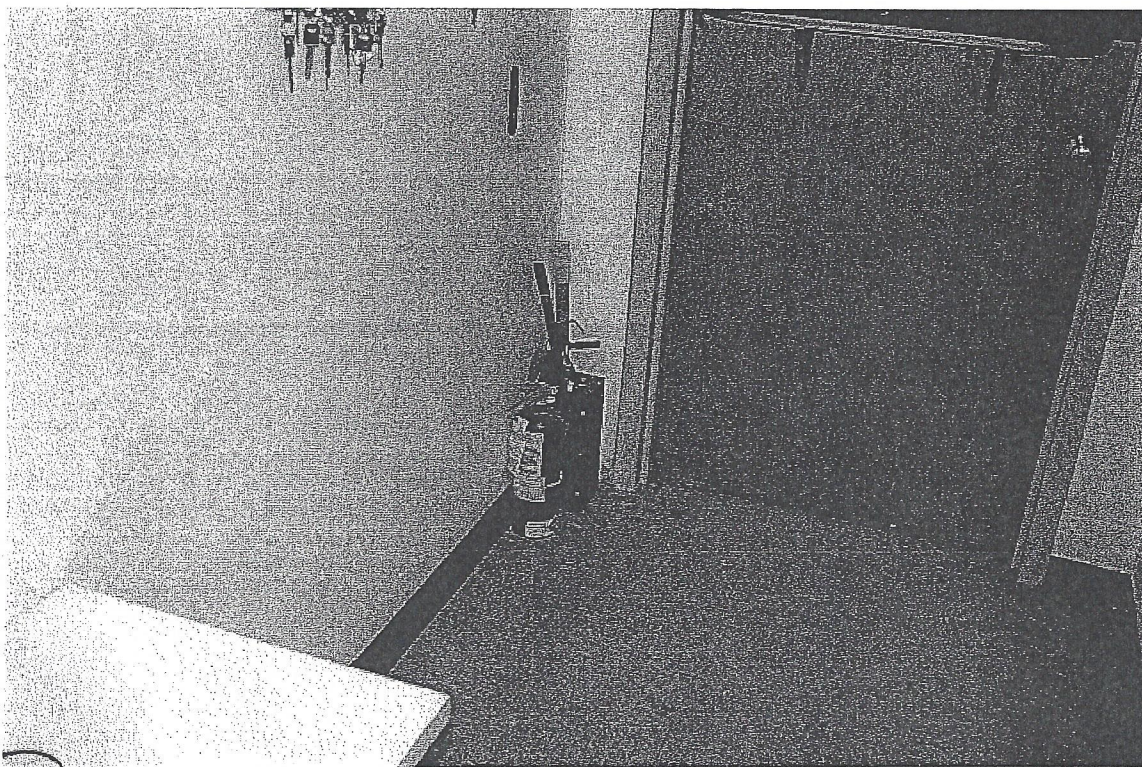
Tools are stored in the corner along with fire suppression equipment.

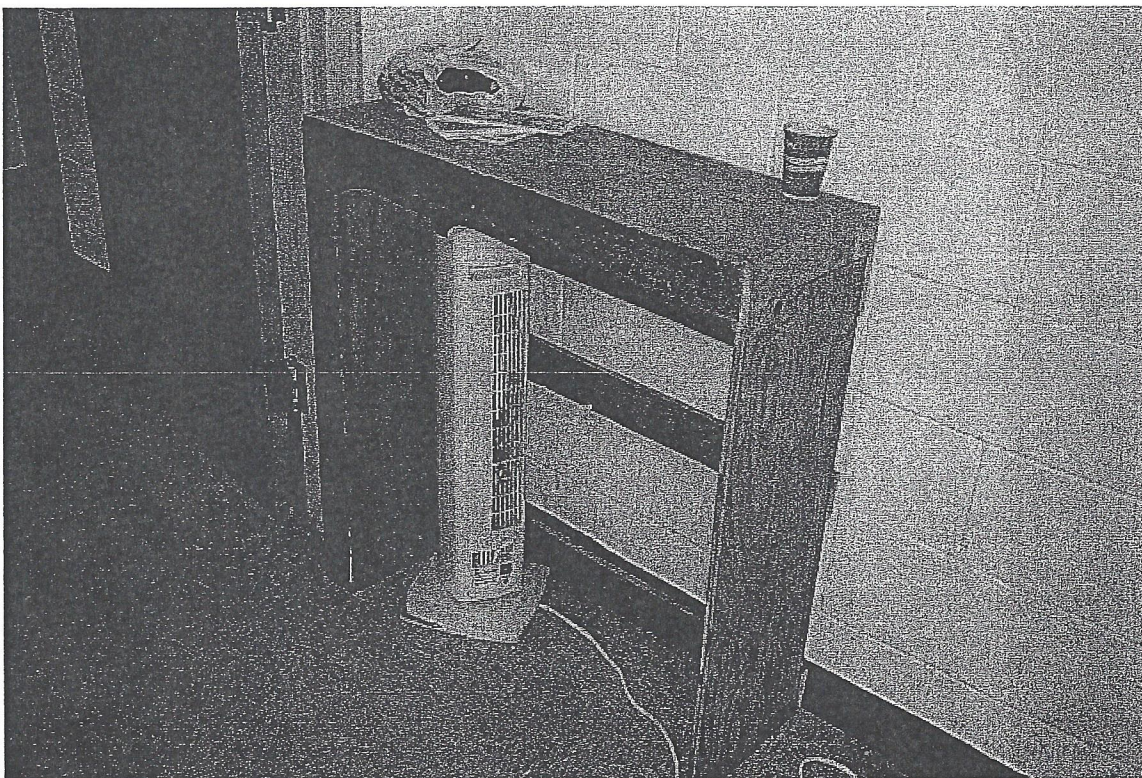
Due to the difficulty in regulating climate in the building, additional appliances must be used to attempt to maintain a comfort level.

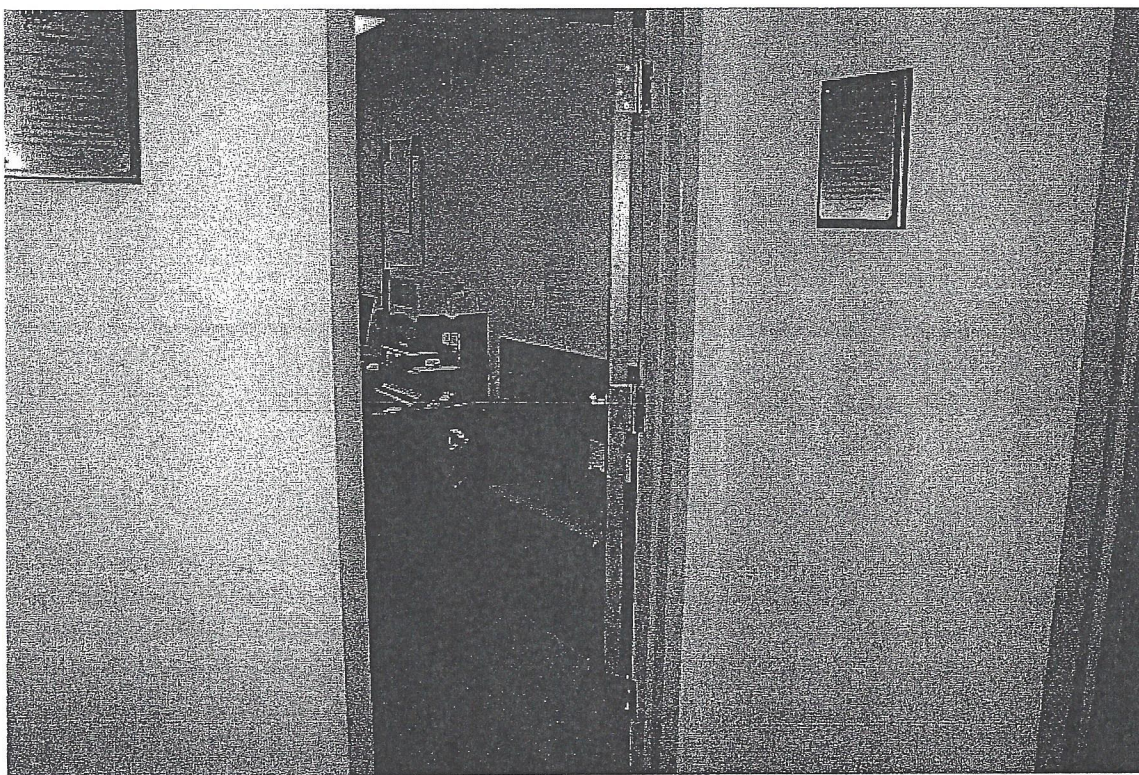
Booking room from hallway allows a prisoner to be viewed by unauthorized personnel.

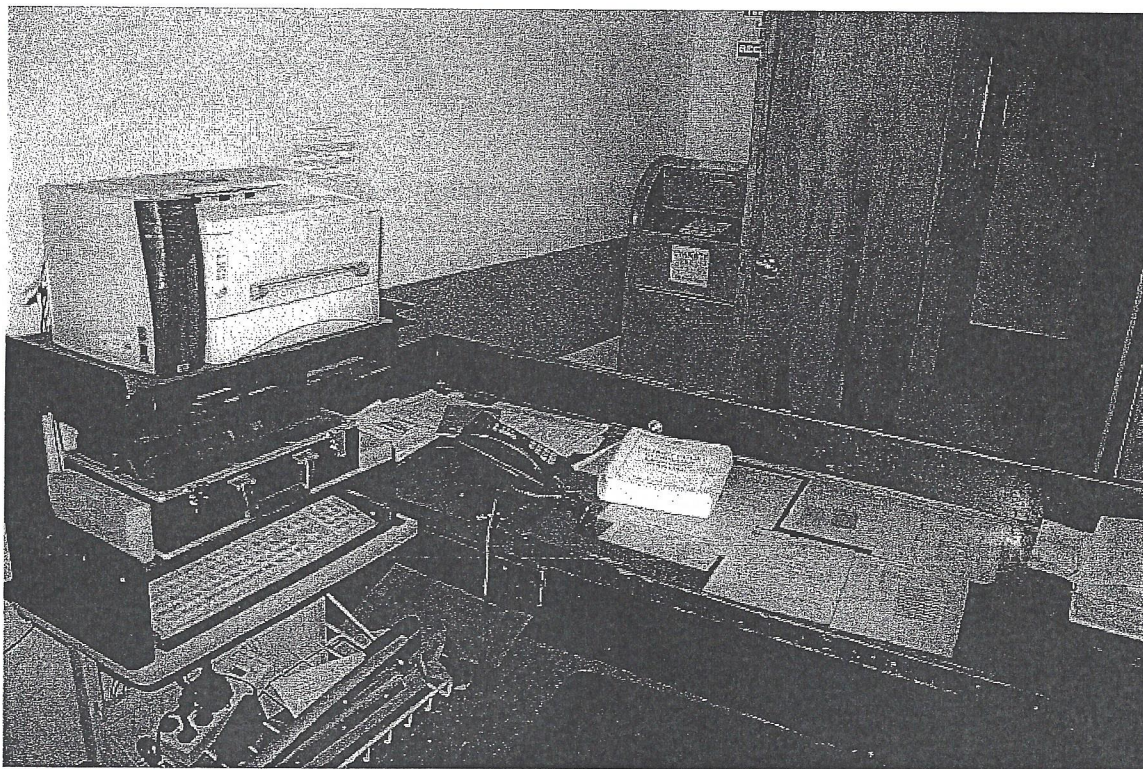
Inadequate booking facilities. No prisoner-only phone, unsafe prisoner-officer design, insufficient space for multiple prisoners, lack of a decontamination area for officers.

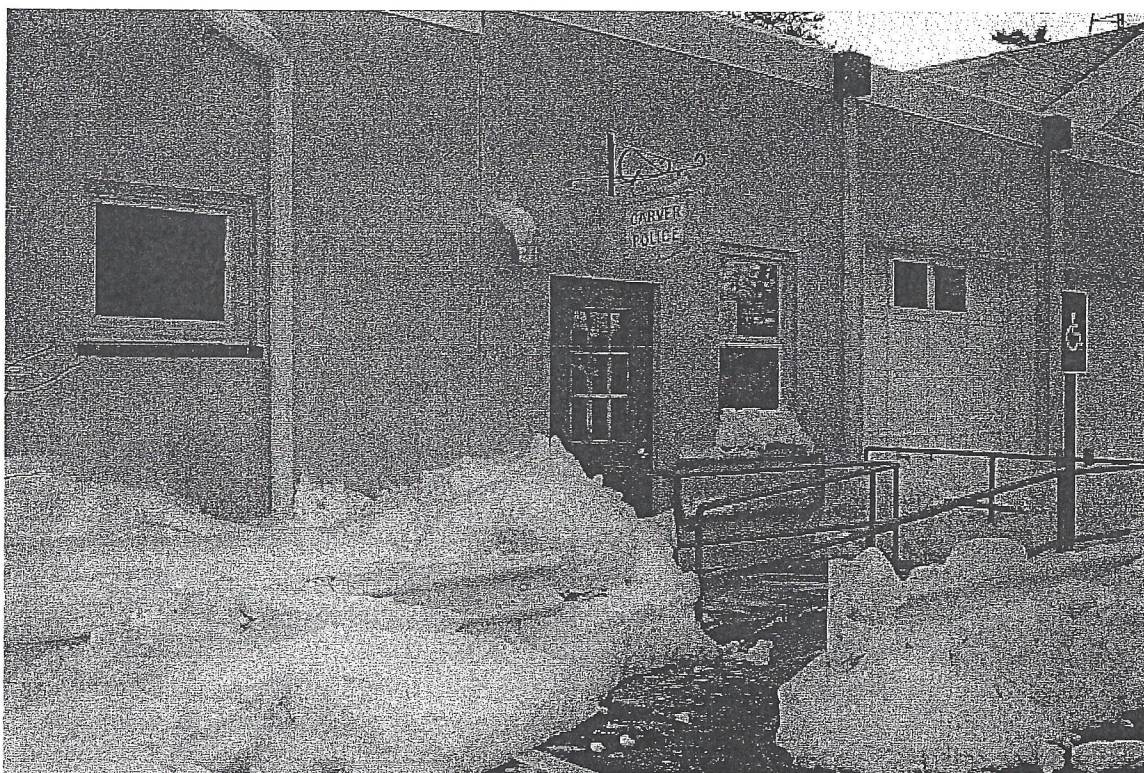
Inability to access the police station from lobby without going outside to first do so.

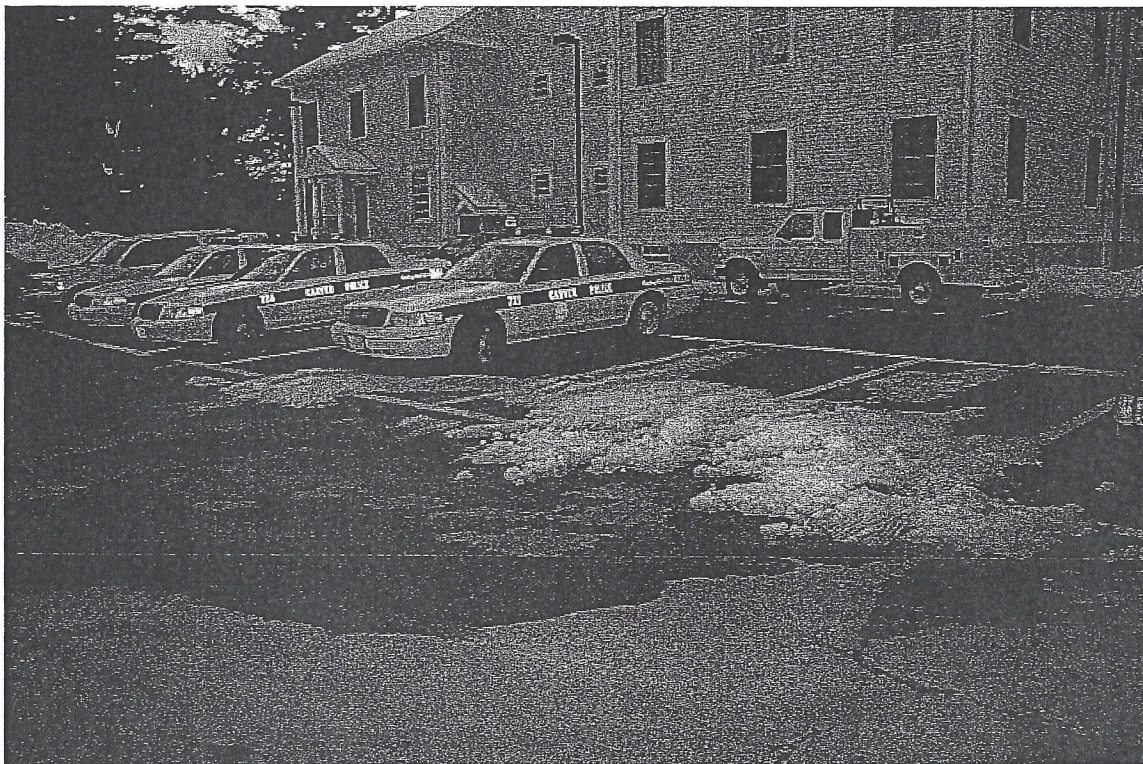
The department's patrol vehicles and officers' personal cars lack the proper security.

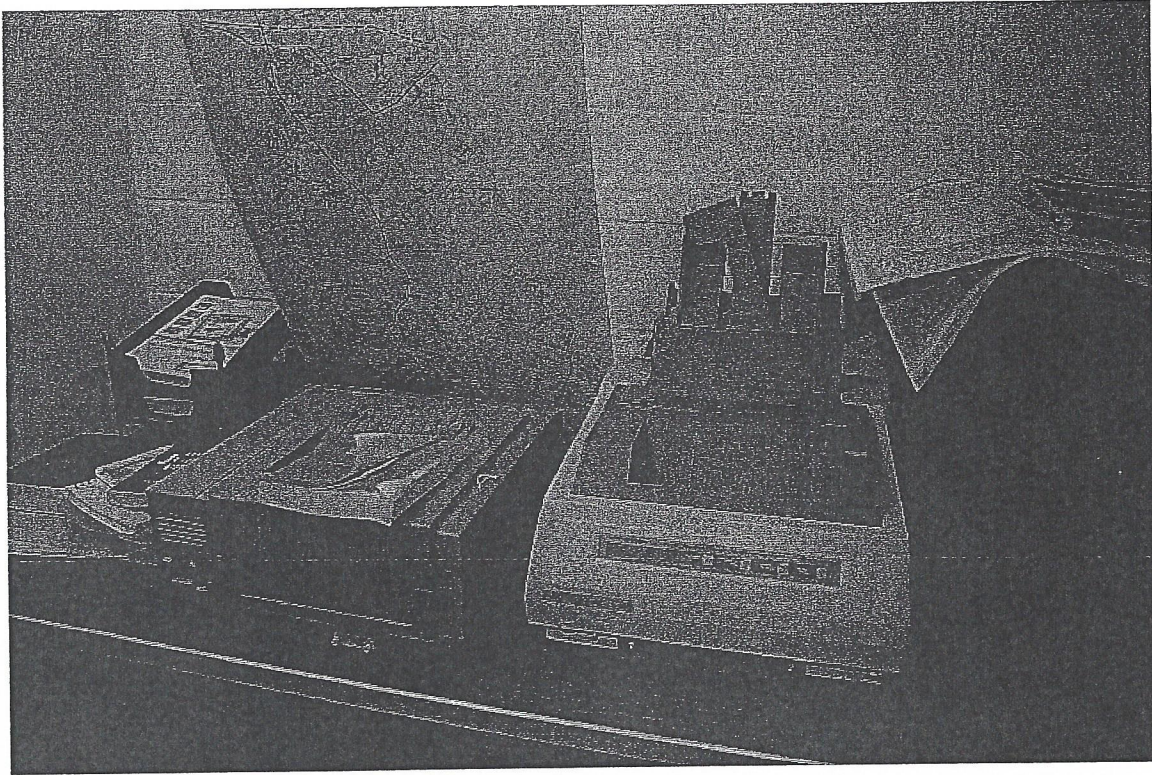
Officer's report writing room. Workspace contains printers.
