POLICE STATION NEEDS ASSESSMENT STUDY FOR

**CARVER
POLICE DEPARTMENT**

5. LIST of PRESENT CARVER POLICE STATION DEFICENCIES and EXISTING CONDITIONS

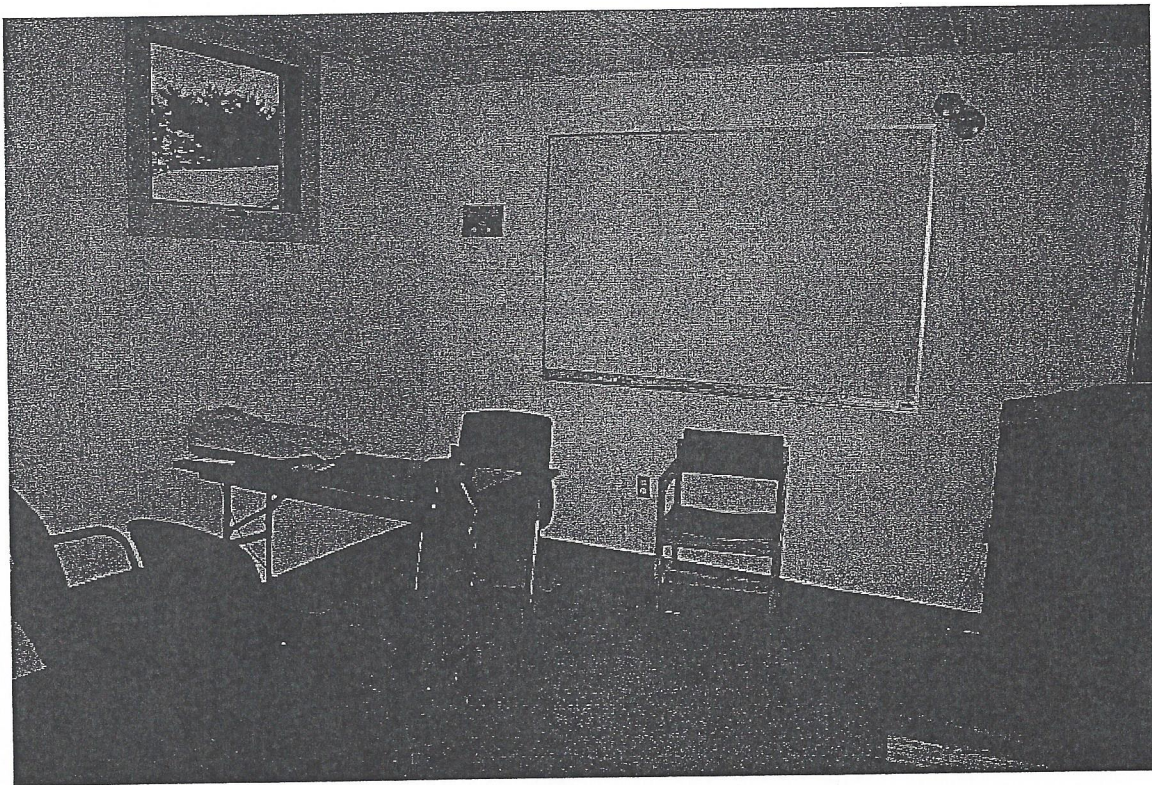
The officer's roll call room doubles as a room the public waits in and meet with officers. The problem is the heat cannot be regulated for this room and it is constantly cold.

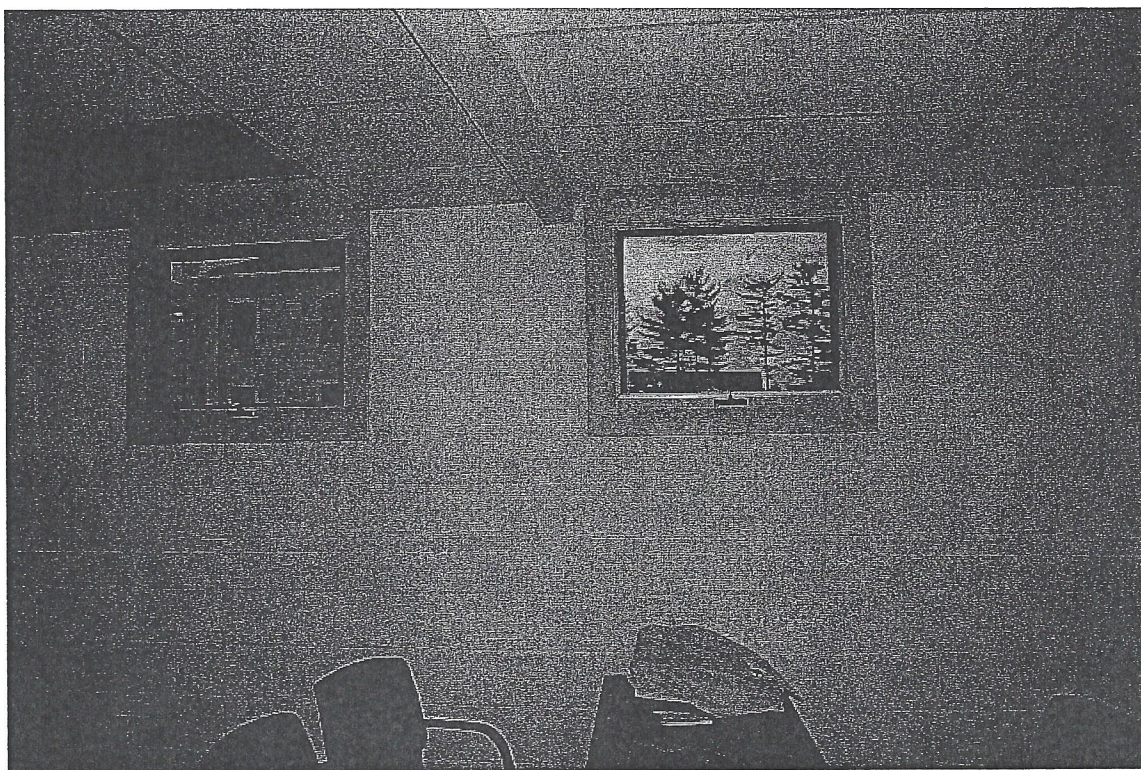
Inadequate windows, lack of insulation and climate control.

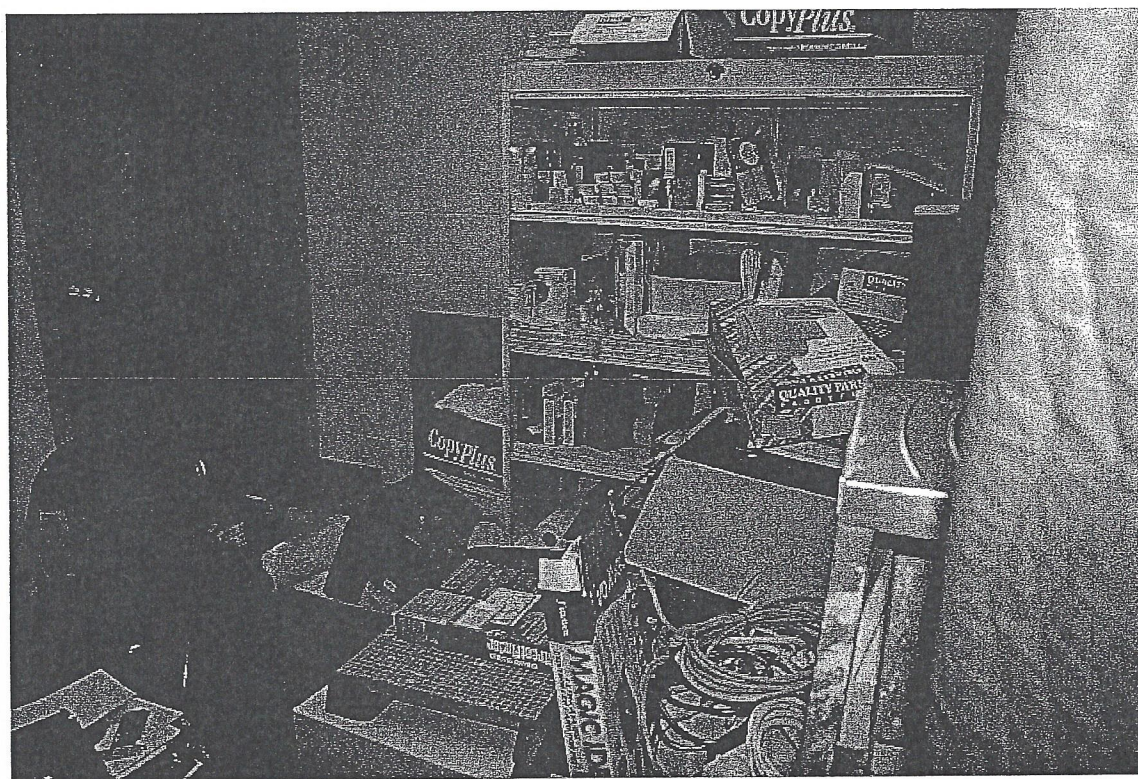
Unsecured storage of office supplies in same room that houses the department's computer infrastructure computer room. This room lacks proper HVAC for computer operation.

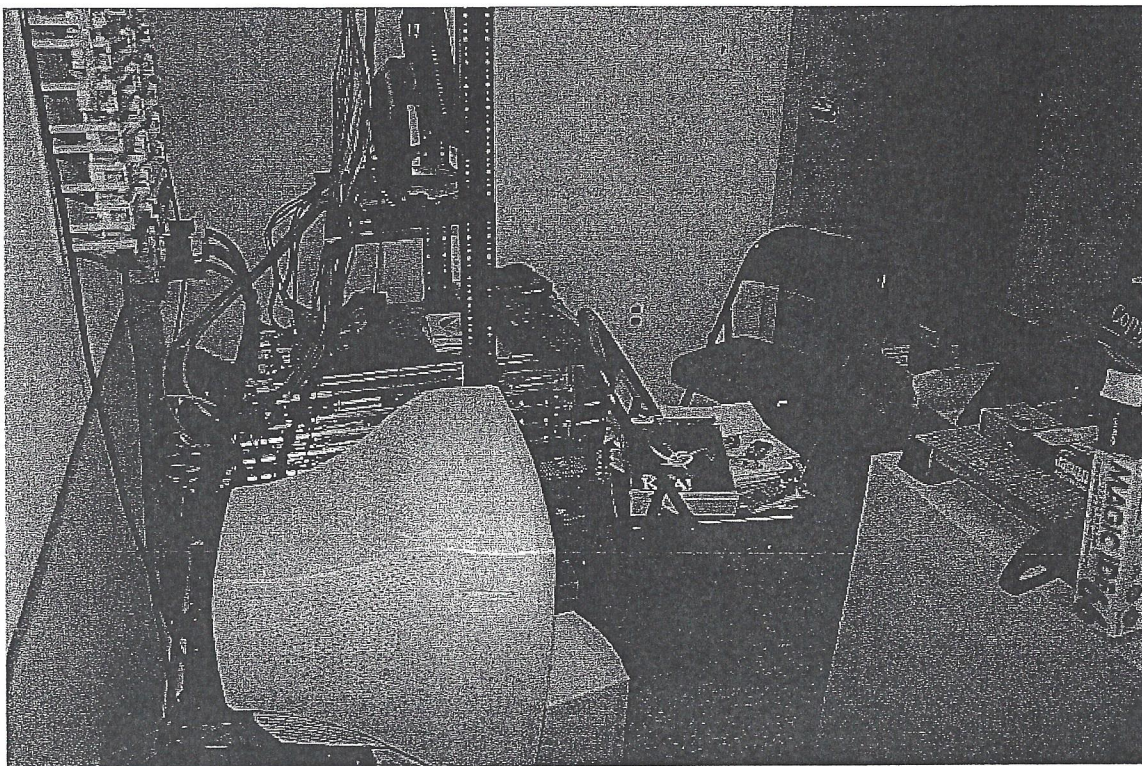
Unsecured storage of office supplies in same room that houses the department's computer infrastructure computer room. This room lacks proper HVAC for computer operation.

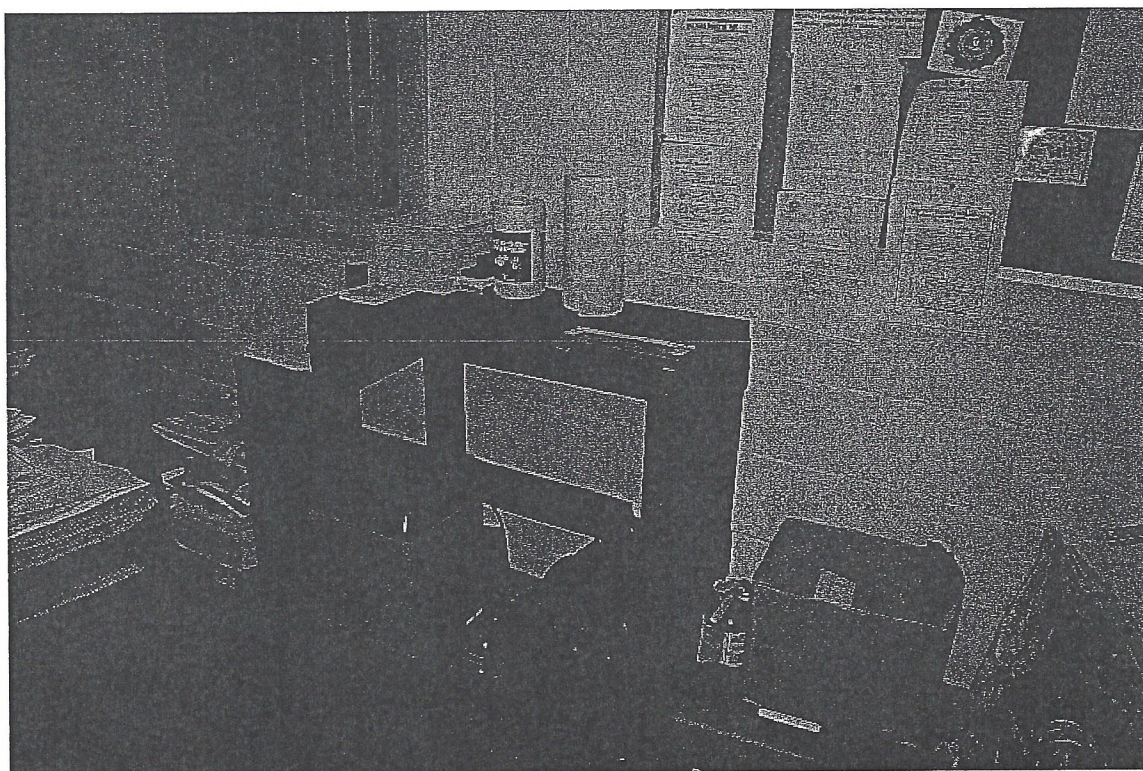
The public's fingerprint area for licensing in the Administrative Sergeants' office. Note the storage of medical and other equipment on the floor.

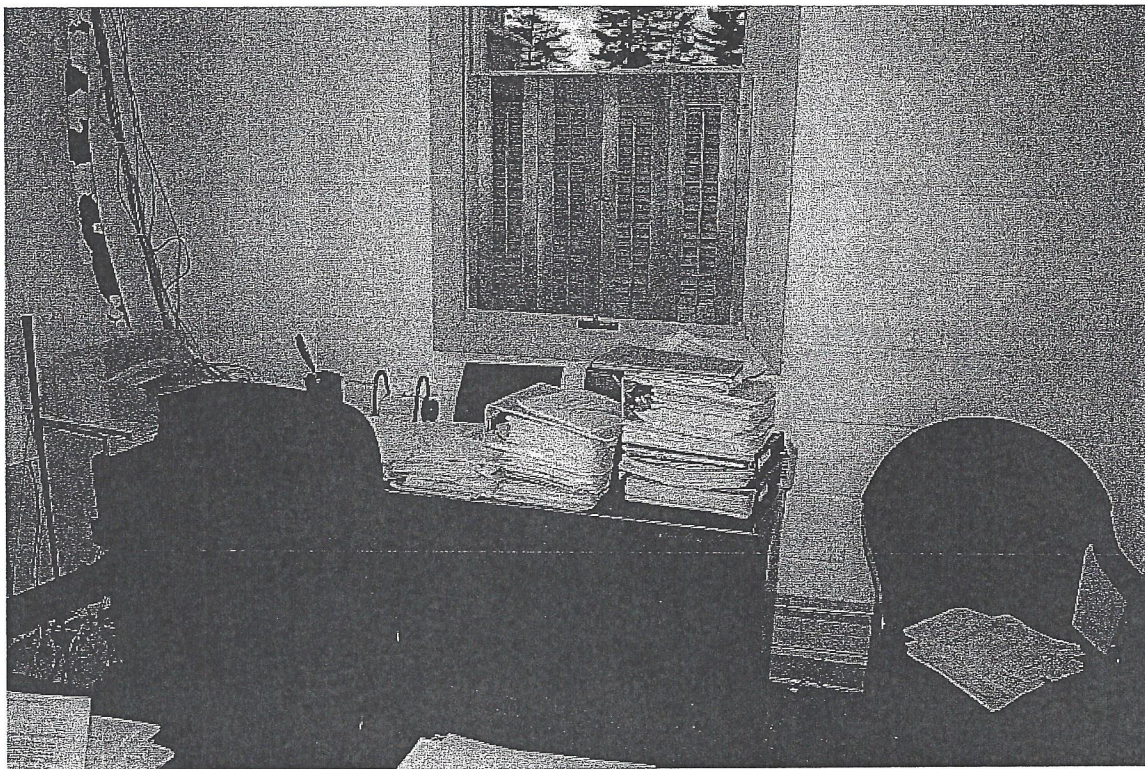
Storage of paperwork and books on workspace area.

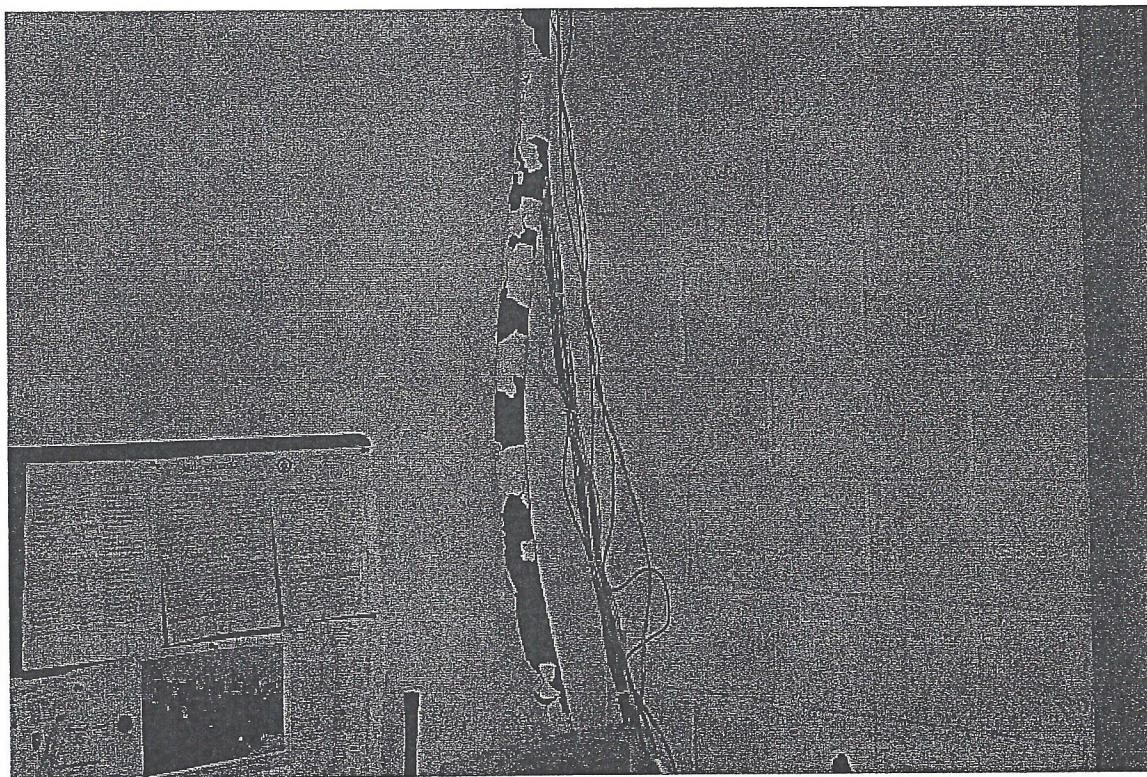
Exposed wires and conduct carrying utilities create an unprofessional atmosphere.

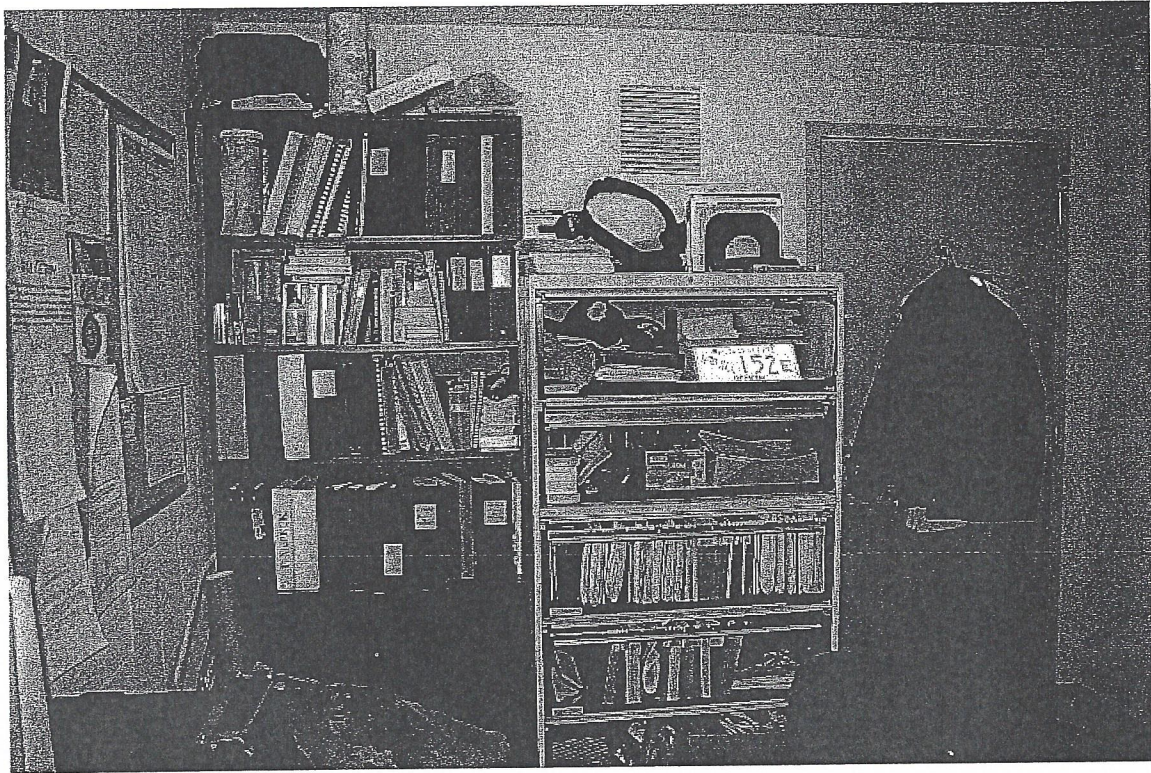
Storage gives an unprofessional appearance in an office.

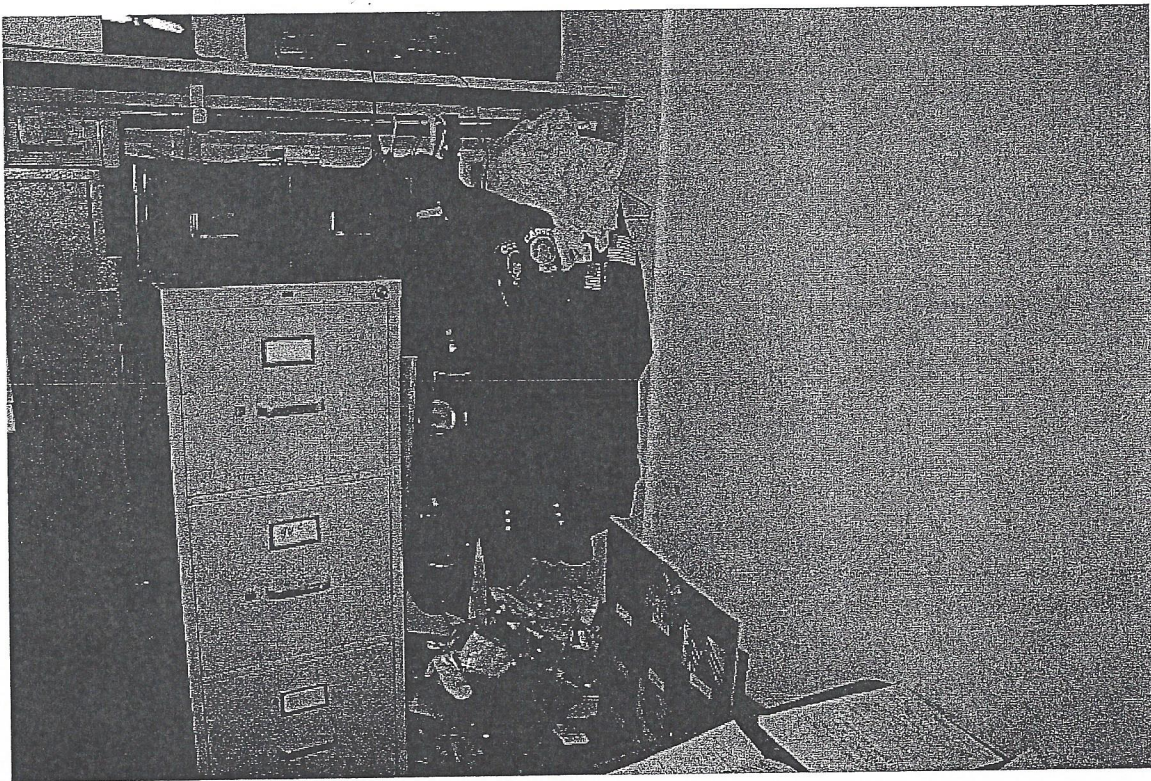
Inadequate areas to store department equipment.

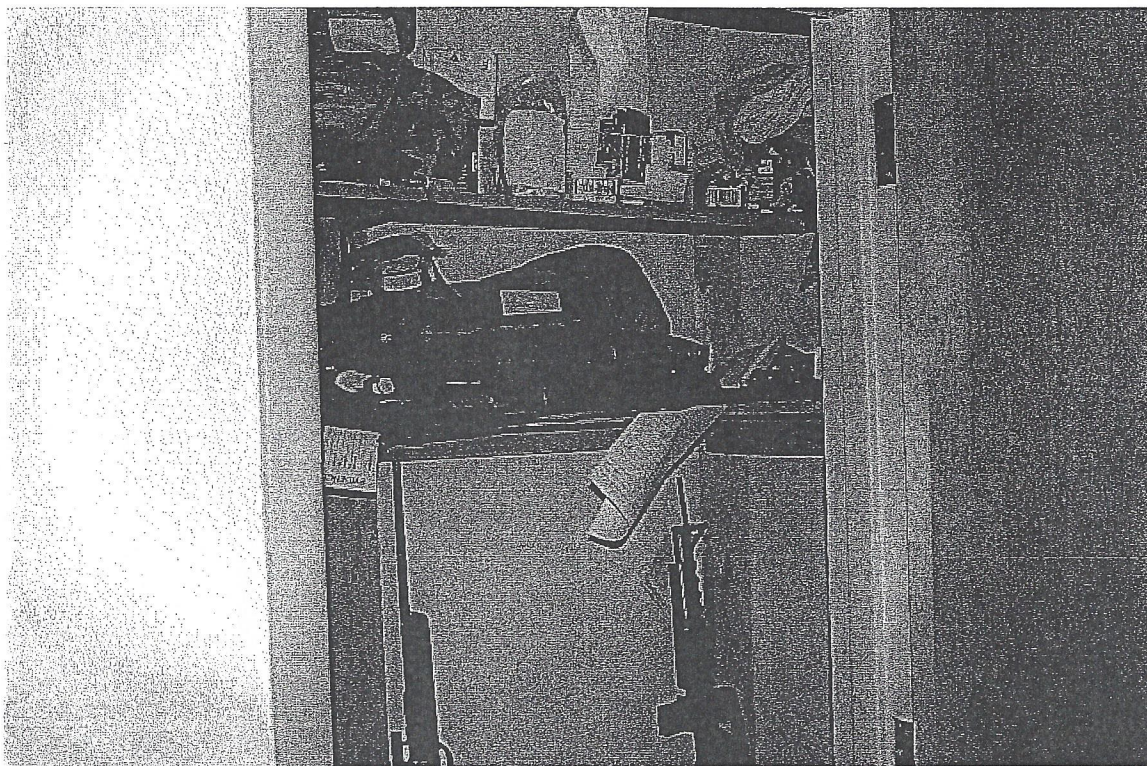
Improper storage of weapons seized pursuant to restraining orders etc.

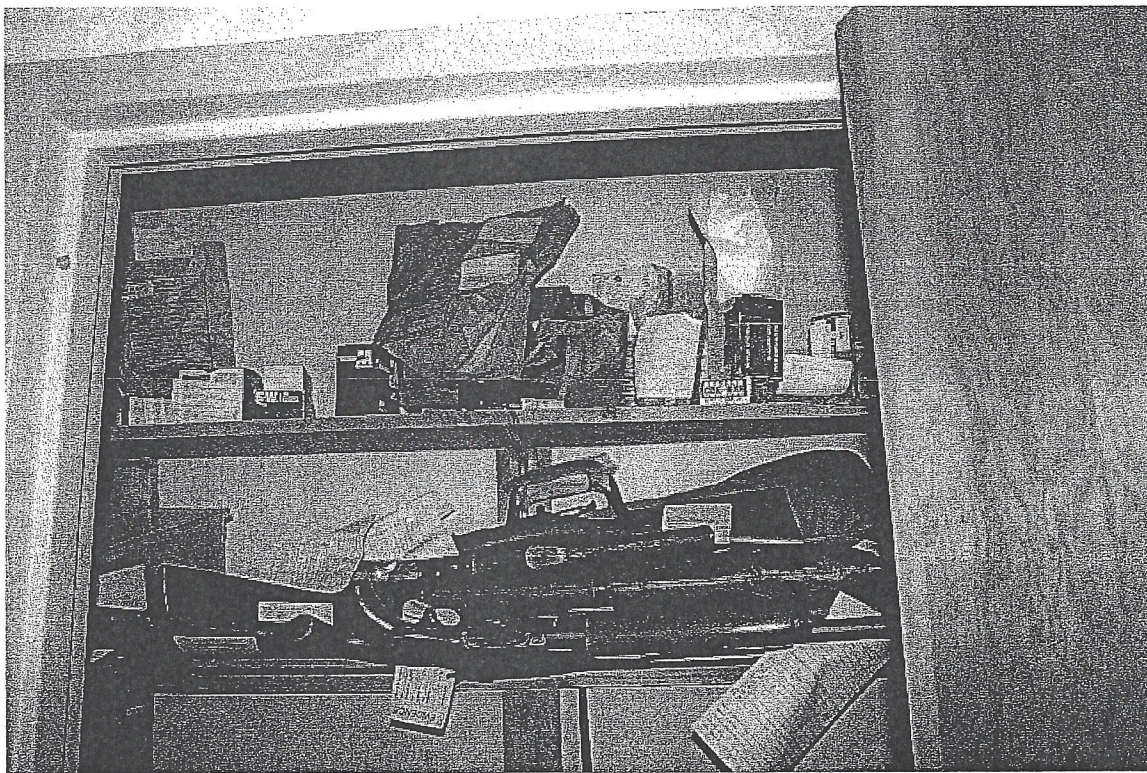
Improper ammunition storage in the non-fire resistant closet.

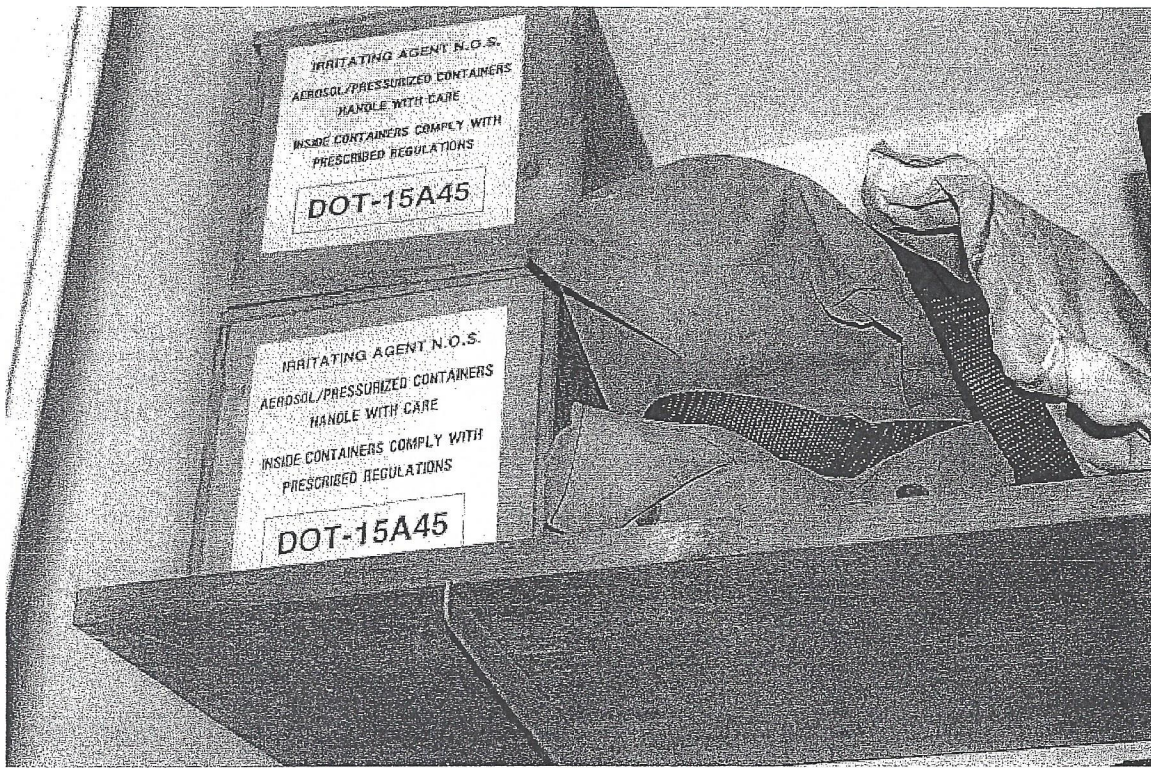
Storage of this type of equipment should be the proper storage areas.

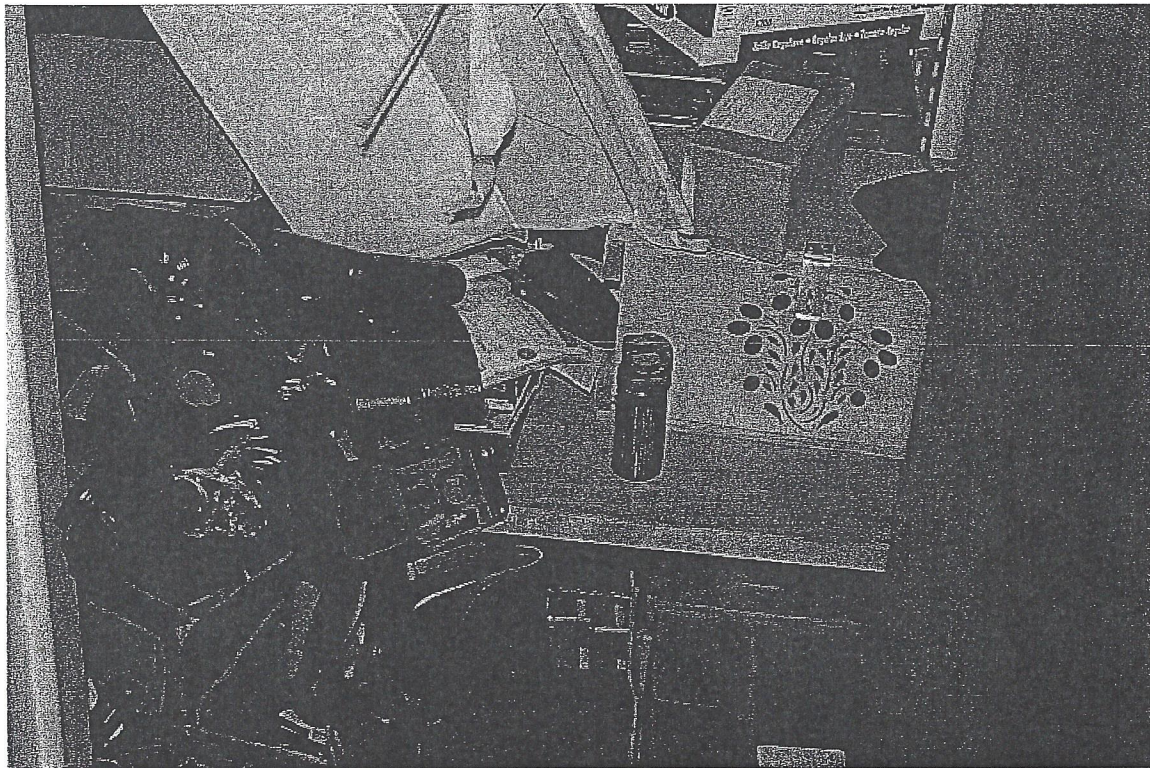
Inadequate storage areas for department equipment.

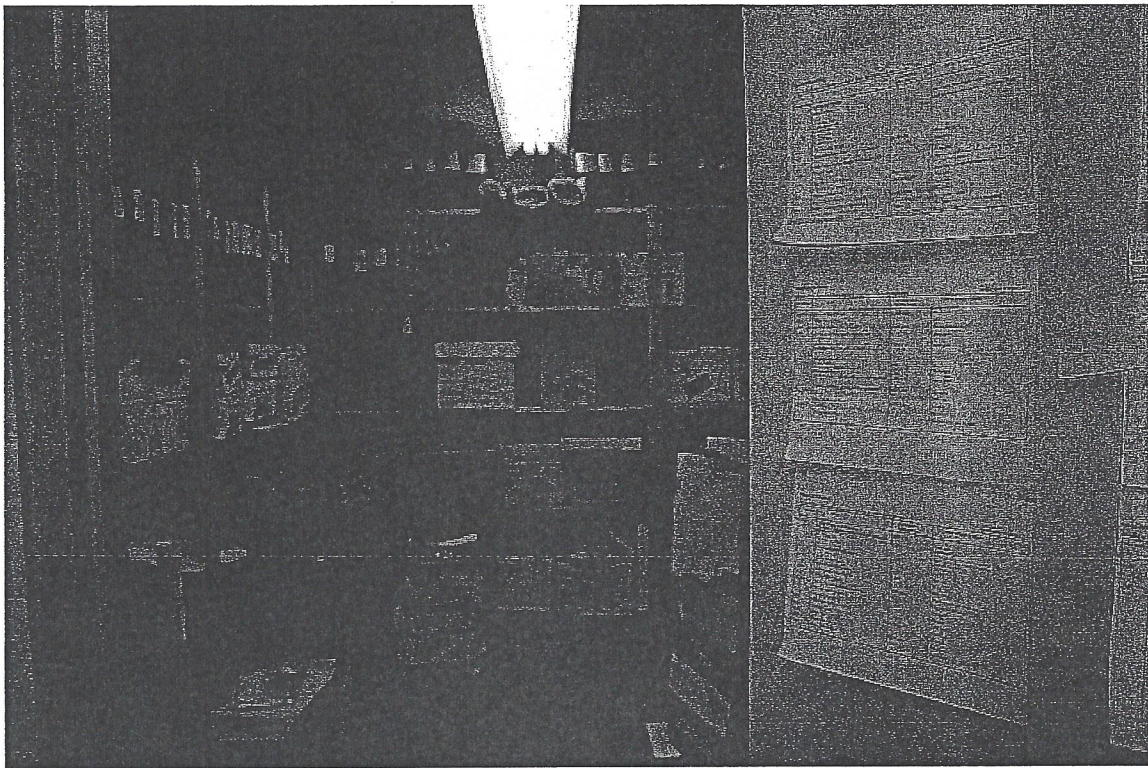
Lack of waterproof, fireproof archives for permanent records.

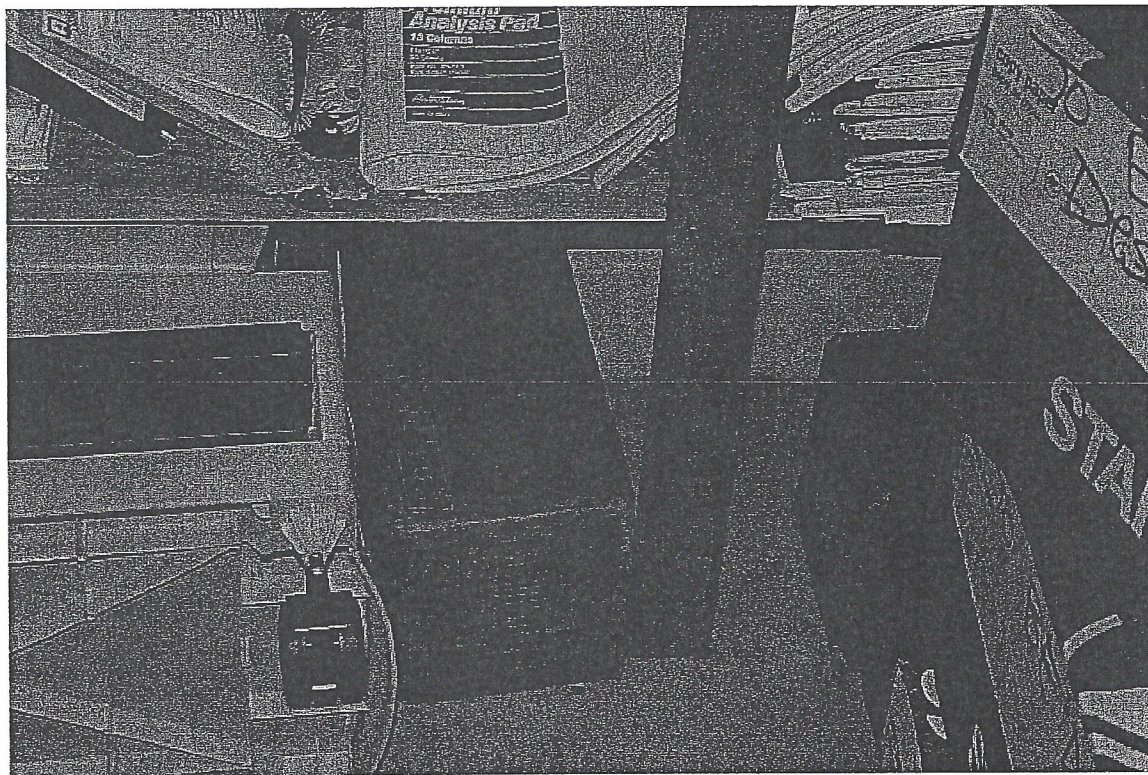
Improper storage of ammunition in the records room.

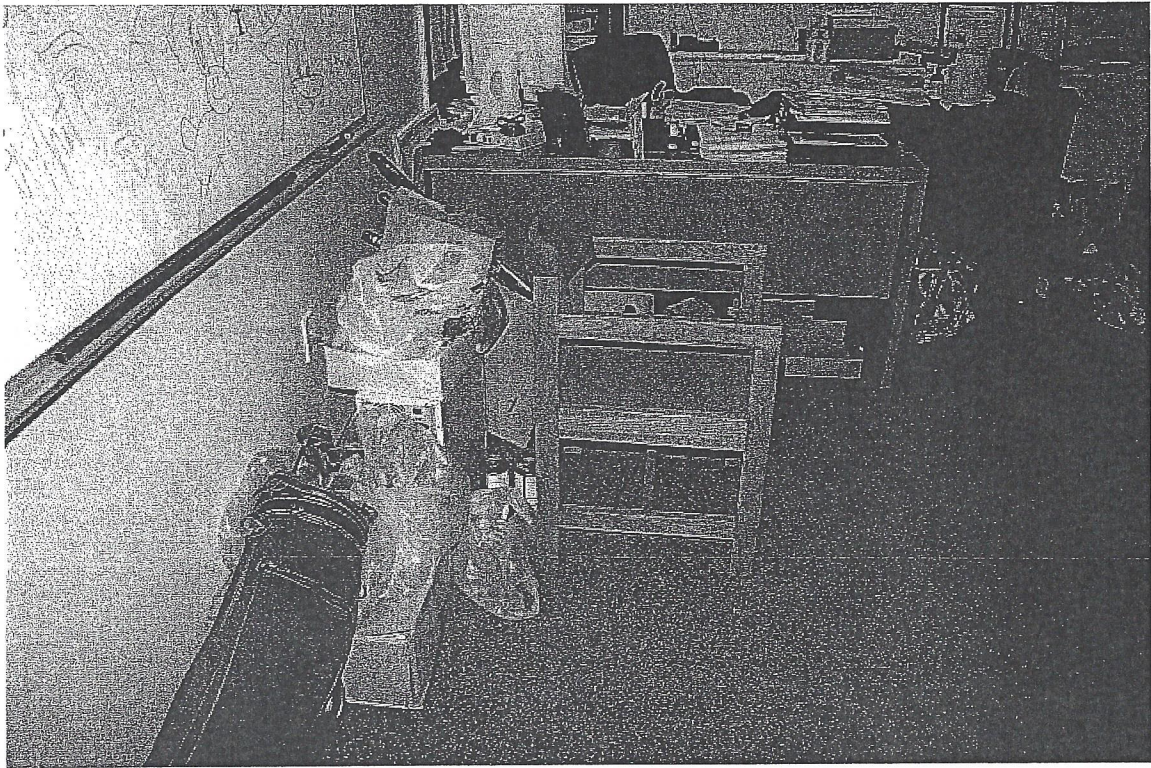
Lack of storage results in items improperly placed in prosecutors/community resource officer's workstation.
