## M E M O R A N D U M

RE: Linbias Path Subdivision

Fuss & O'Neill (F&O) conducted a site walk on May 25, 2020 to observe the general status of the subdivision, recommend a bond amount for remaining work, and assist the Planning Board with determining if the subdivision is being constructed in accordance with the approved plan set prepared by Webby Engineering (dated March 3, 2016), landscape plans prepared by Wet Tech Land Design (dated March 5, 2016), and special permit (dated November 17, 2016). Please note that the decision references a plan set dated October 4, 2016 that was not provided to F&O, which is believed to include a road shift of 2.73 feet east and revised buffer along western property line. However, not having a plan(s) depicting these revisions did not affect F&O's ability to provide a bond estimate.

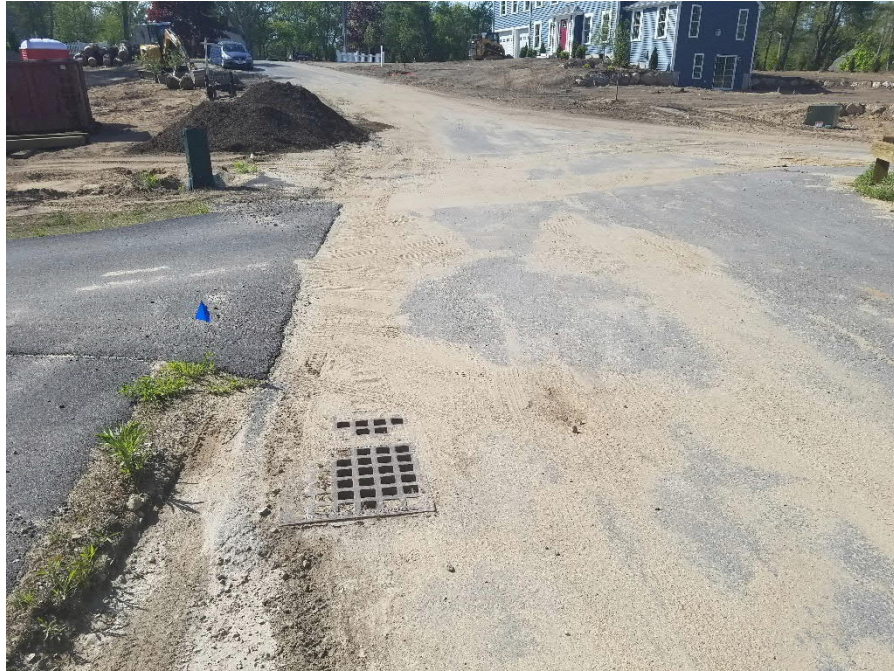
Photo 2: Catch basin requiring sediment removal and inlet protection

1. A quote was provided by the developer, Mike Facchini, from Truax Corporation for paving the surface course, sidewalk, and berm. These items were broken out individually in the estimate (Photo 155527).
2. The existing catch basin inlet protection has holes in it and must be replaced. Since the drainage system has been exposed to sediment loads without inlet protection, a line item for cleaning the drainage structures (including drain manholes) has been included in the estimate (Photo 160706).
  - a. During maintenance, confirm hoods were/are installed on catch basins.
3. Riprap energy dissipator shall be installed at outfall behind Lots 2 & 3 (Photo 162504).

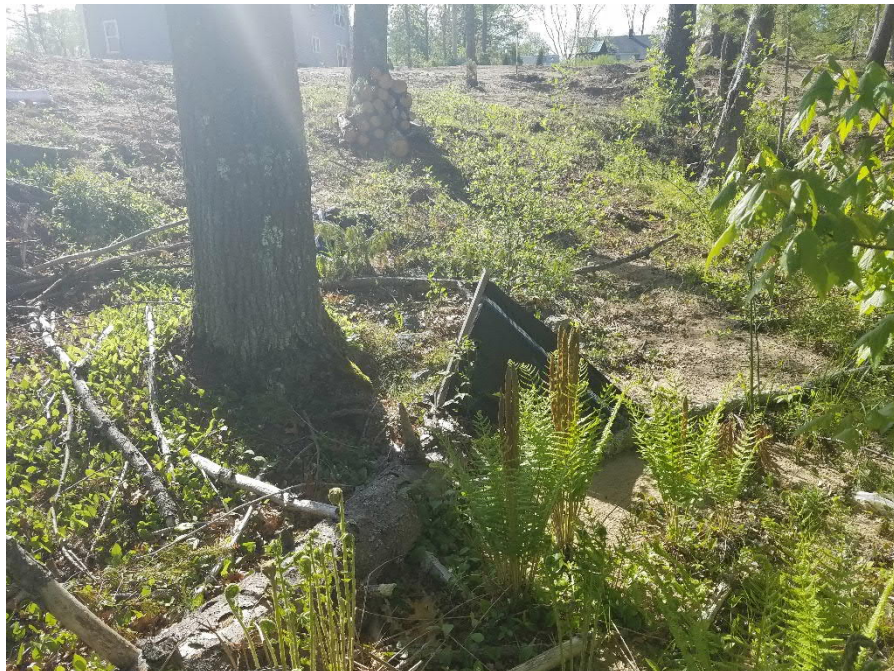
Photo 3: Outfall requiring sediment removal, riprap, and wattles

4. Straw wattles shall be installed at the bottom of the hill to protect the bioretention basin from sedimentation, and at the outfall behind Lots 2 & 3. Sediment already accumulated within the bioretention basin and at the outfall must be removed. Sediment at the outfall location must be removed by hand in order to minimize any damage/disturbance of wetlands (Photo 160105).

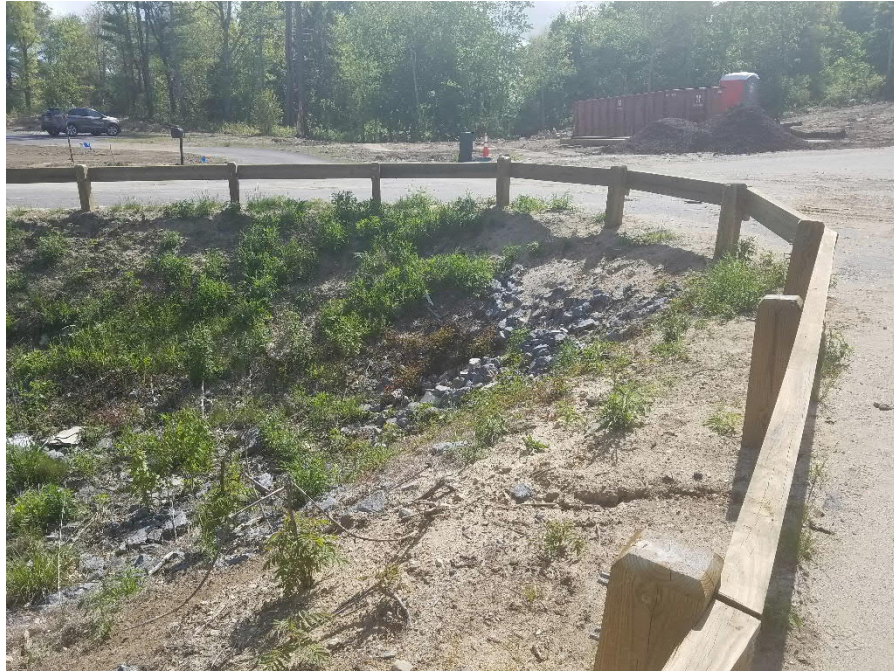
Photo 4: Bioretention basin requiring sediment removal and wattles

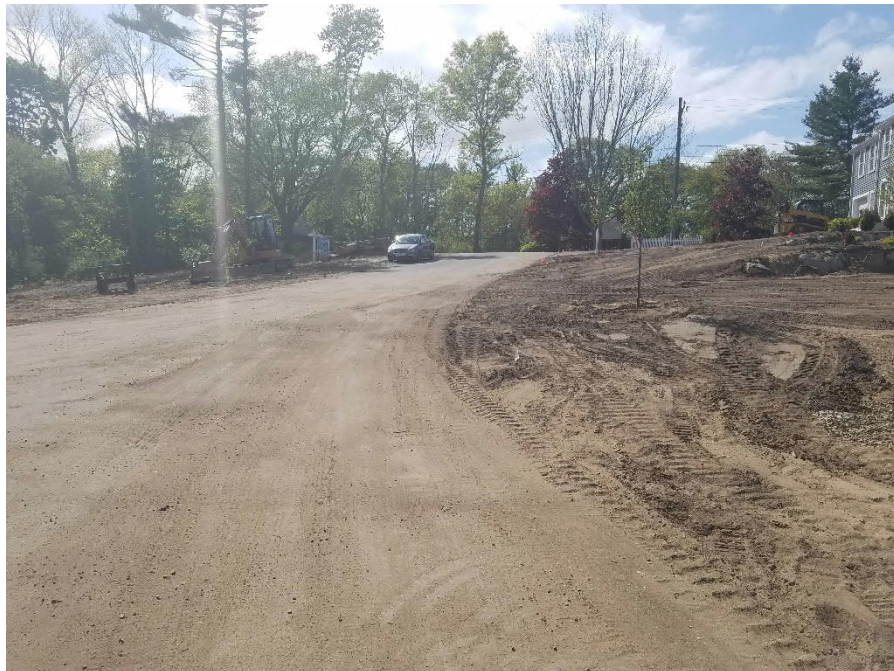
Photo 5: Roadway in front of Lot 2

5. Roadway shall be swept and a construction entrance installed/maintained during construction of Lot 6 (Photo 160852).
6. Erosion and sediment controls shall be maintained until subdivision lots are stabilized.

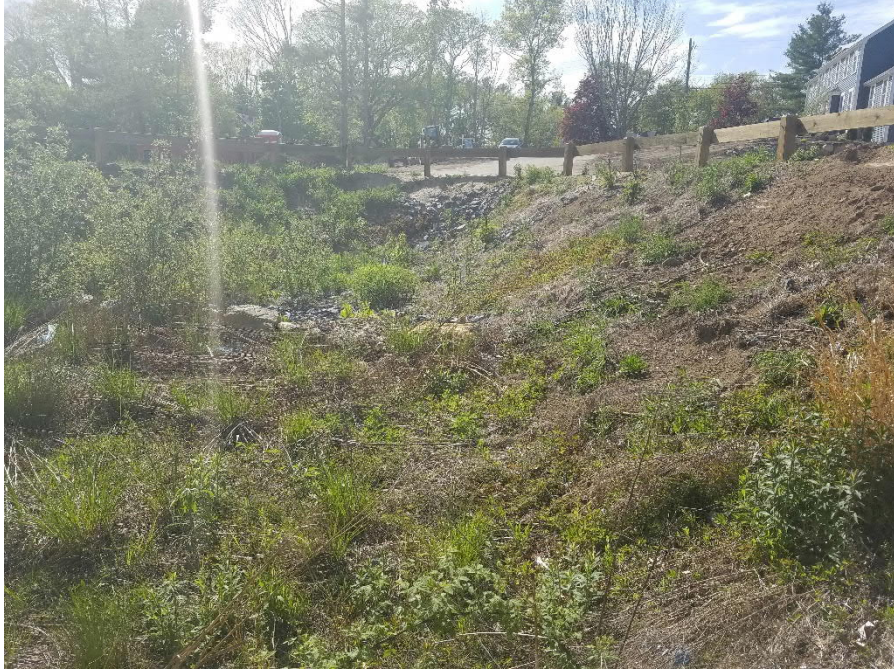
Photo 6: Bioretention basin

7. Loam and seed right-of-way, including preparing basin for plant material.
8. A quote was provided by the developer, Mike Facchini, from Capeway Wholesale Nursery for plant materials. The unit price for this items in the estimate was increased to account for installation costs. Install remaining street trees and plant material within bioretention basin in accordance with landscape plans prepared by Wet Tech Land Design, Inc (Photo 160352).

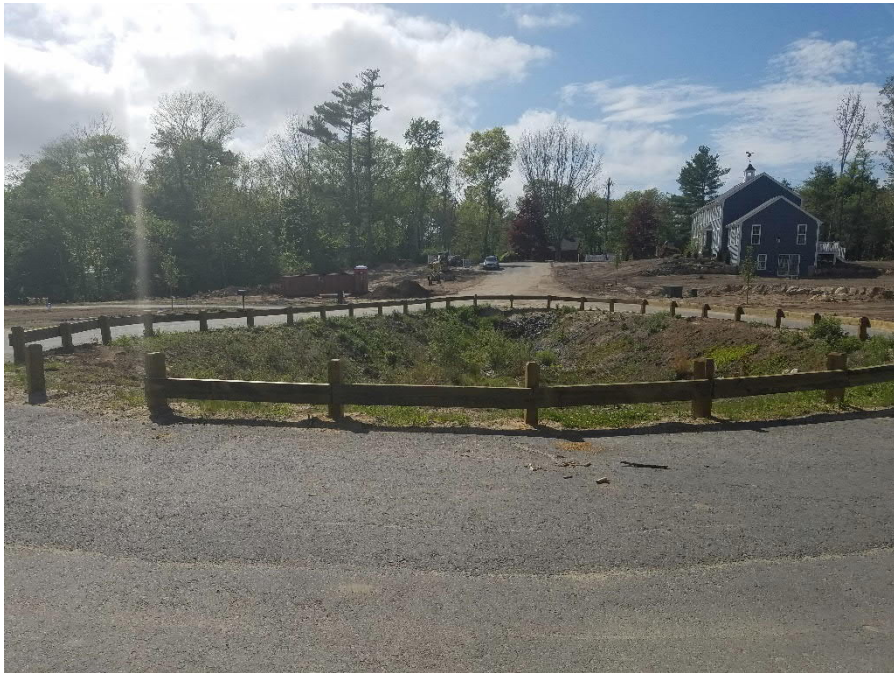
Photo 7: Guard rail and bioretention basin

9. Install remaining portion of guard rail, and ensure 2 bolts per rail are installed at each post connection (Photo 160522).
10. Maintain plant material until roadway acceptance by Town.

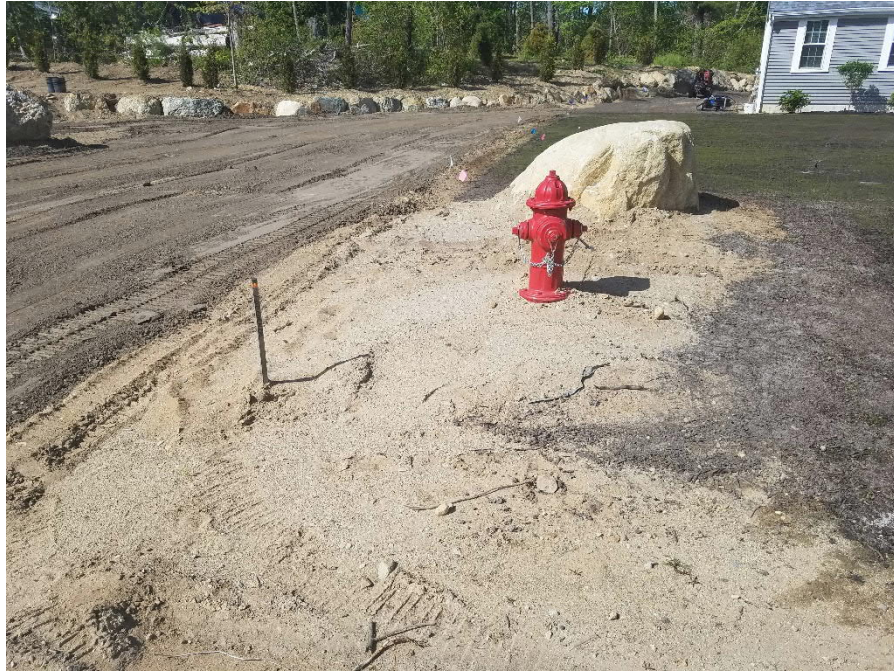
Photo 8: Hydrant where gate valve could not be located

- c. Gate valve for fire hydrant could not be located during this inspection and is believed to be buried on Lot 2, outside of the roadway pavement. Gate valve must be raised to finish grade and included in the as-built. If the gate valve is not located within the right-of-way, an easement will need to be established (Photo 160438).
