POLICE STATION NEEDS ASSESSMENT STUDY FOR

**CARVER
POLICE DEPARTMENT**

5. LIST of PRESENT CARVER POLICE STATION DEFICENCIES and EXISTING CONDITIONS

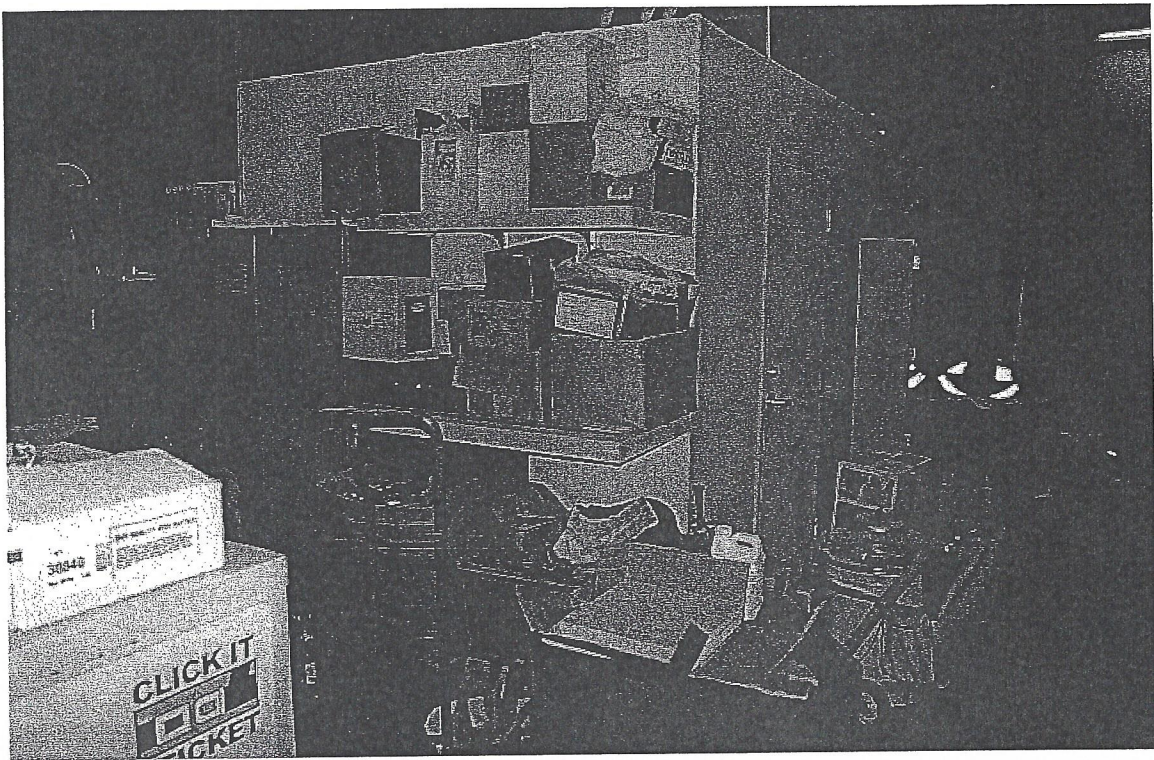
The white door in the center of this picture is the secure, alarmed door to the evidence room where non-drug, drug and firearms evidence is currently stored.

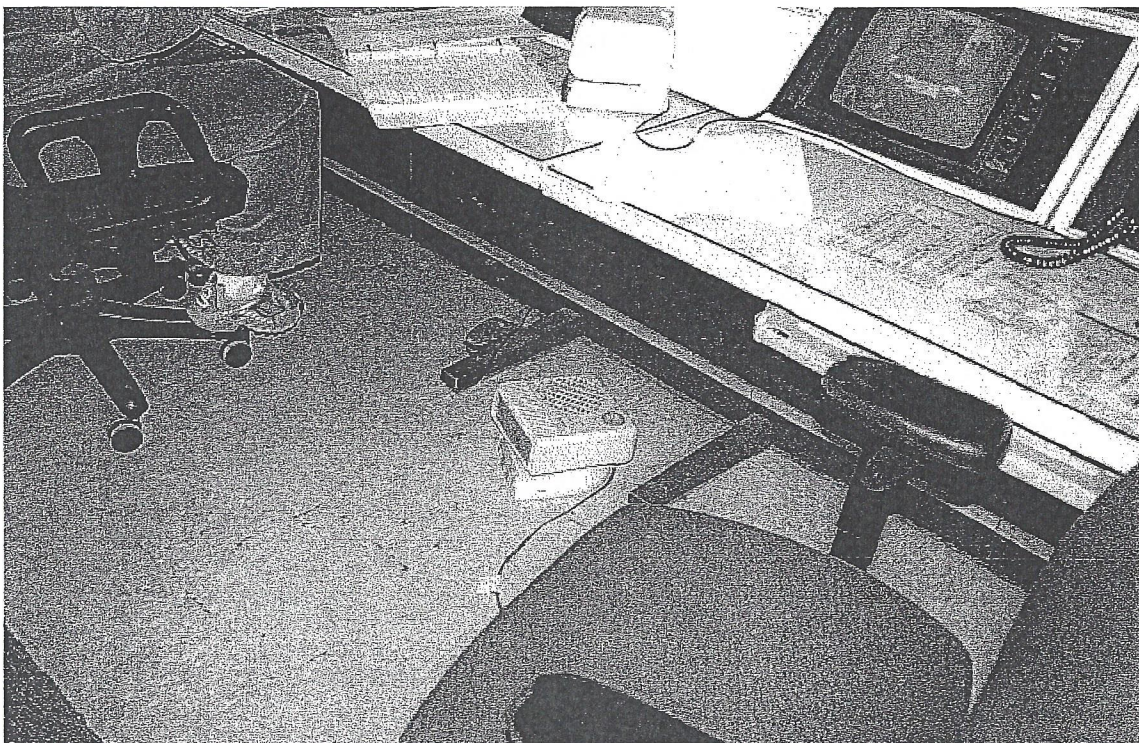
Due to the difficulty in regulating climate in the building, additional appliances must be used to attempt to maintain a comfort level.

The only regulated heat source within the dispatch area currently is this electric heater. This area was one of three garages rehabbed into a dispatch - communications center.

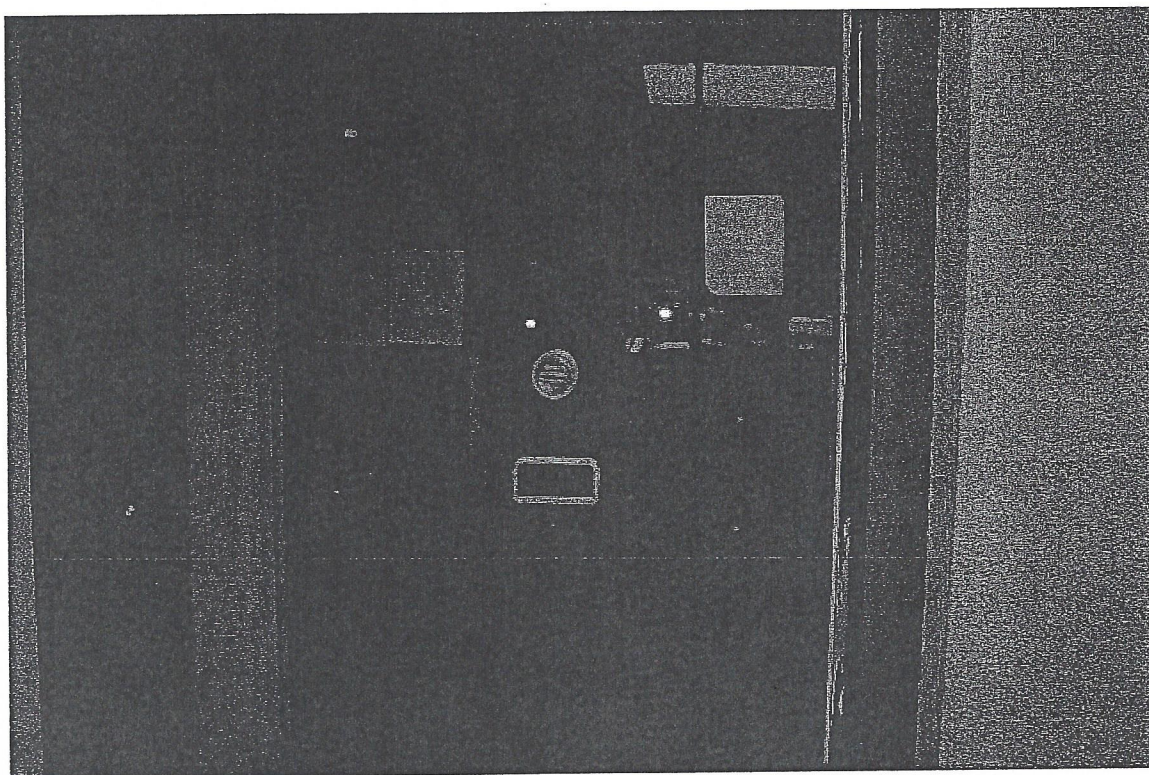
Inability to access the police station from lobby without going outside to first do so.

This is the public's view of the Carver Police Department from the station's lobby.

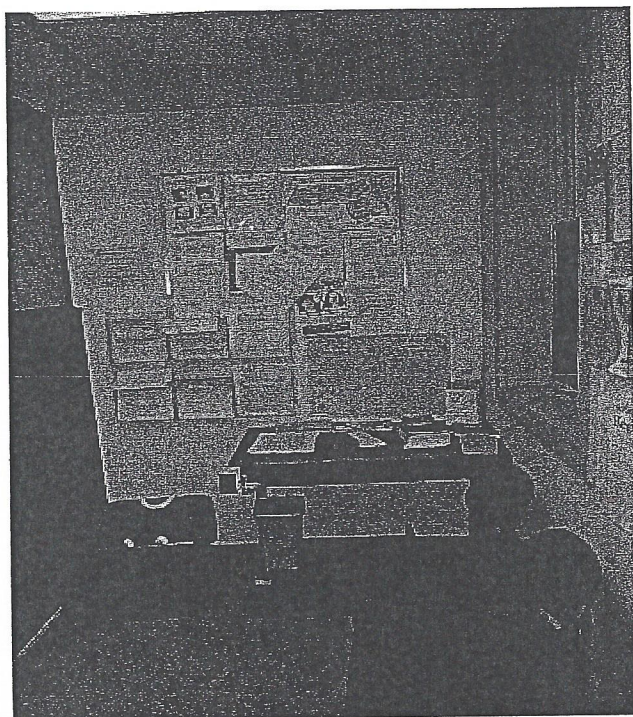
The Carver Police Station Lobby.

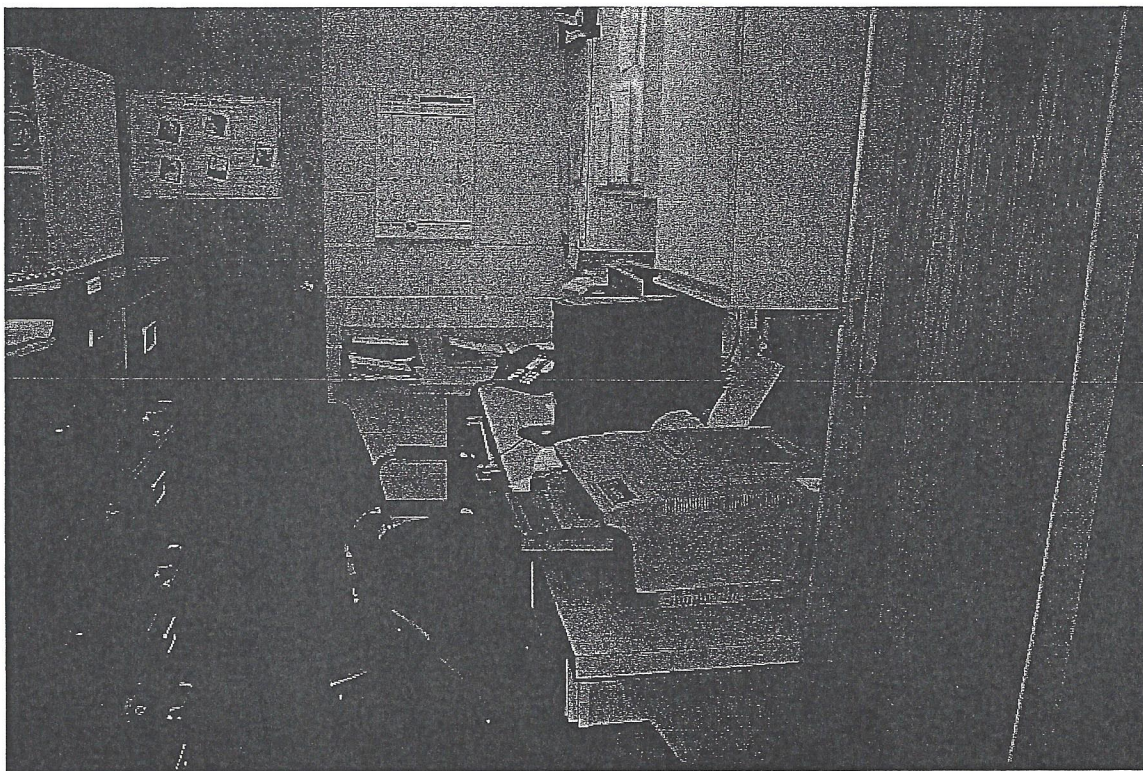
The current officer's work station where officers write their reports and research cases.
